**Appendix K**  
**Other Level Crossing and**  
**Road Rail Interface Issues**  
Photographic Evidence

### K.1 Introduction

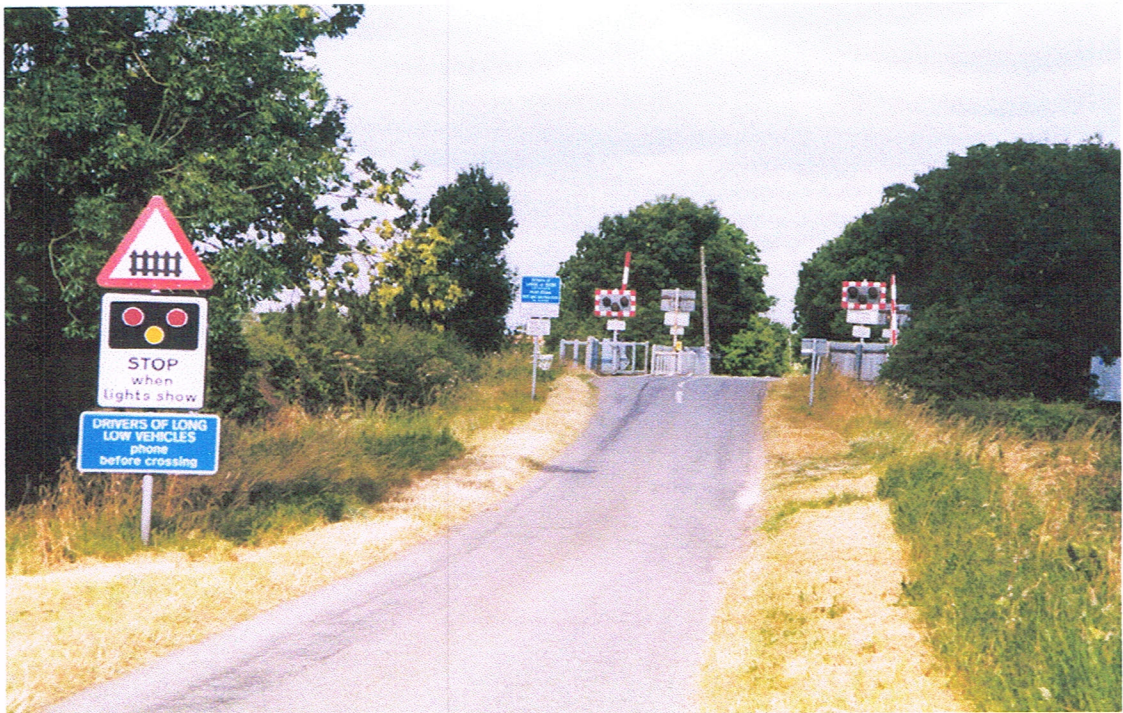
*Figure K.1*

*South Scarle AHB LC in rural Lincolnshire looking north-west. A pleasant level crossing with excellent signposting, barriers and road traffic lights visible from a fair distance.*

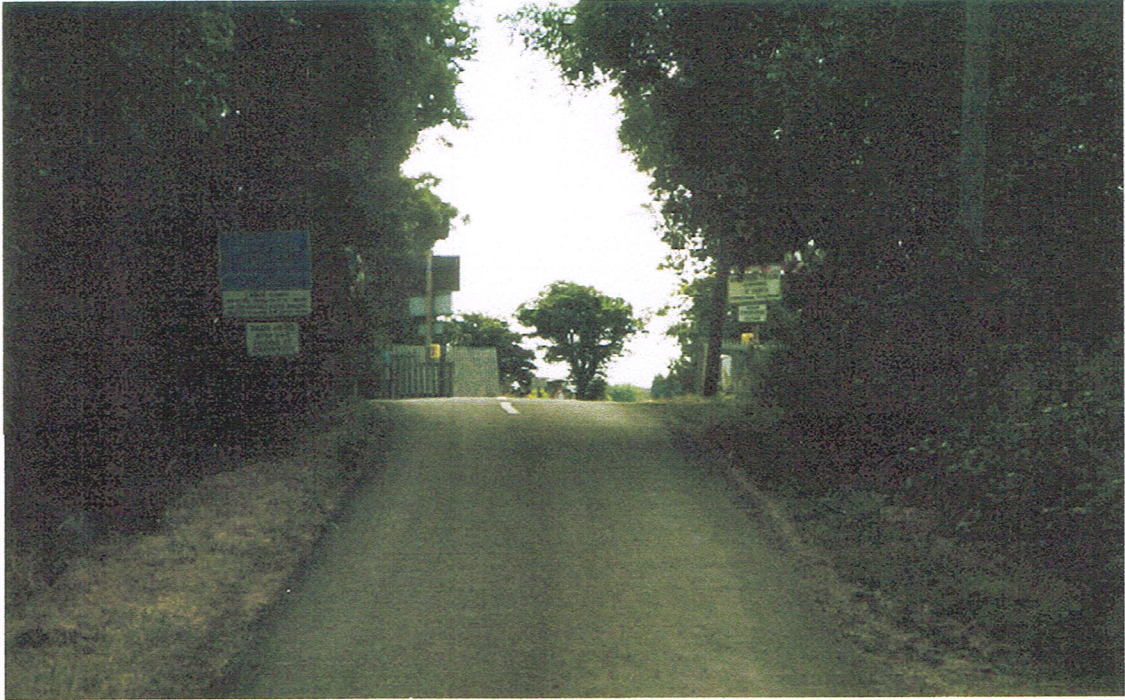
*Figure K.2*

*South Scarle AHB LC in rural Lincolnshire looking south-east a few minutes later. The pleasant level crossing is now a highly dangerous interface to the railway, with the motorist being 'blinded' by the mid-morning sun. Note how the signposts, road signals and level crossing have blended into the vegetation in the surrounding area. If your eyesight is good you may just make out the red and white backboard chequering of the road signals facing the motorist!*

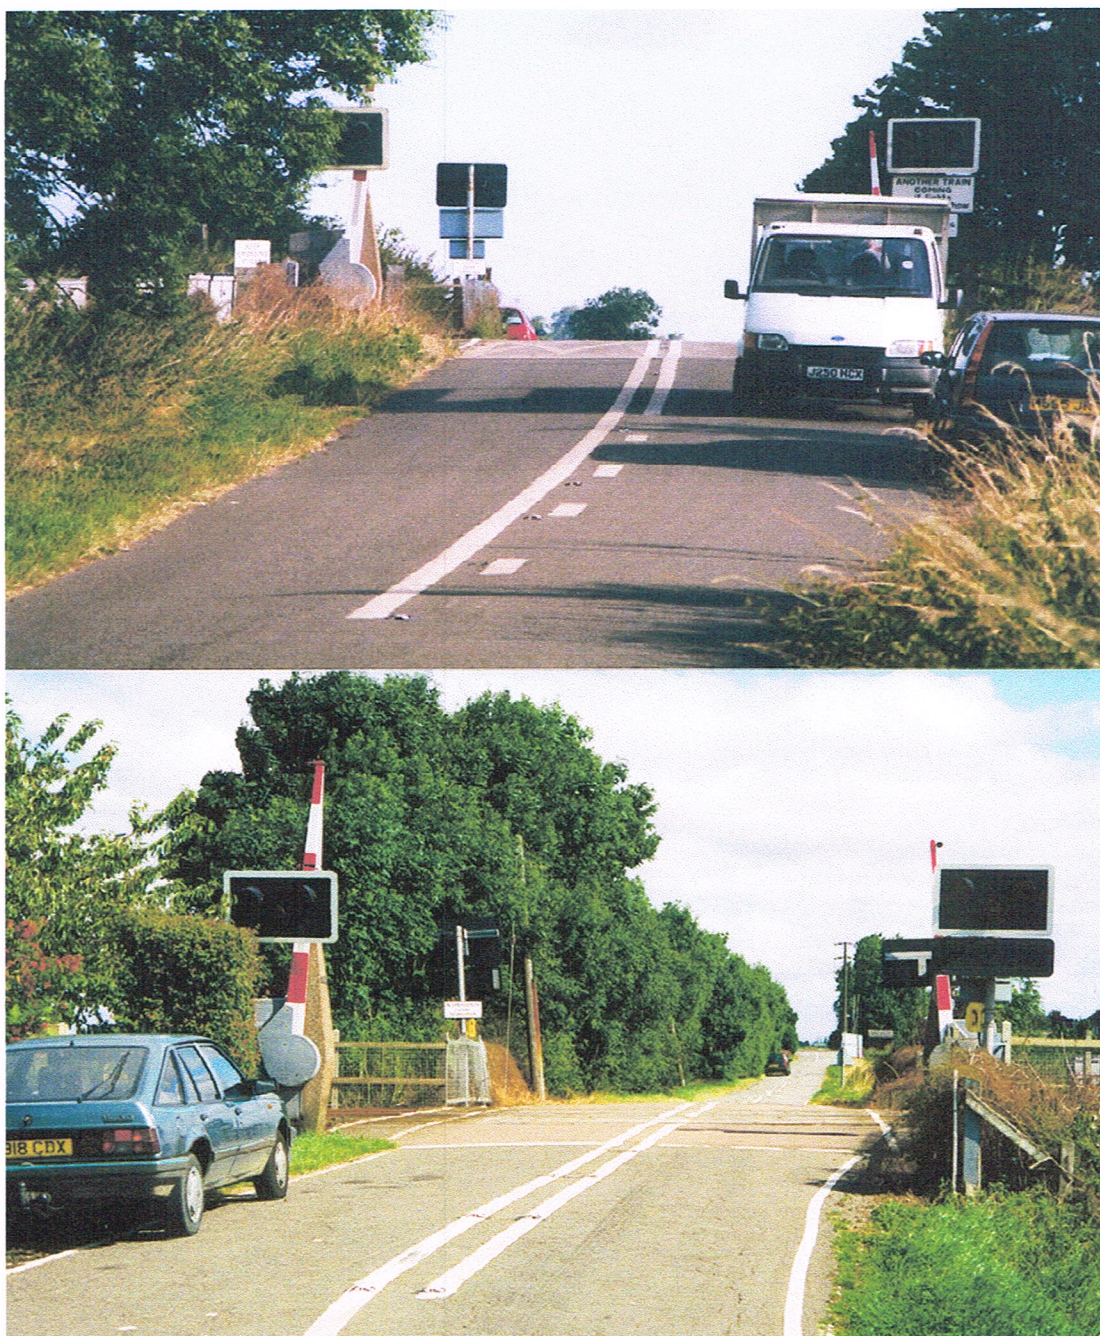
*Figure K.3*

*Moronic and illegal parking! Milkman delivering to the house adjacent to Winthorpe AHB LC, Nottinghamshire (top) and Lucks Road AHB LC, Lincolnshire (bottom) where the house owner has parked within a few metres of the barrier; note hedging is also beginning to obscure the lower side of road traffic signals in both pictures. Note also the lack of backboard chequering and the un-maintainable ATC sign, in the lower picture. At Winthorpe a motorist travelling towards the camera will be in a very dangerous position if a vehicle is proceeding the other way as he reaches the crown of the level crossing and finds the milk float blocking his exit.*

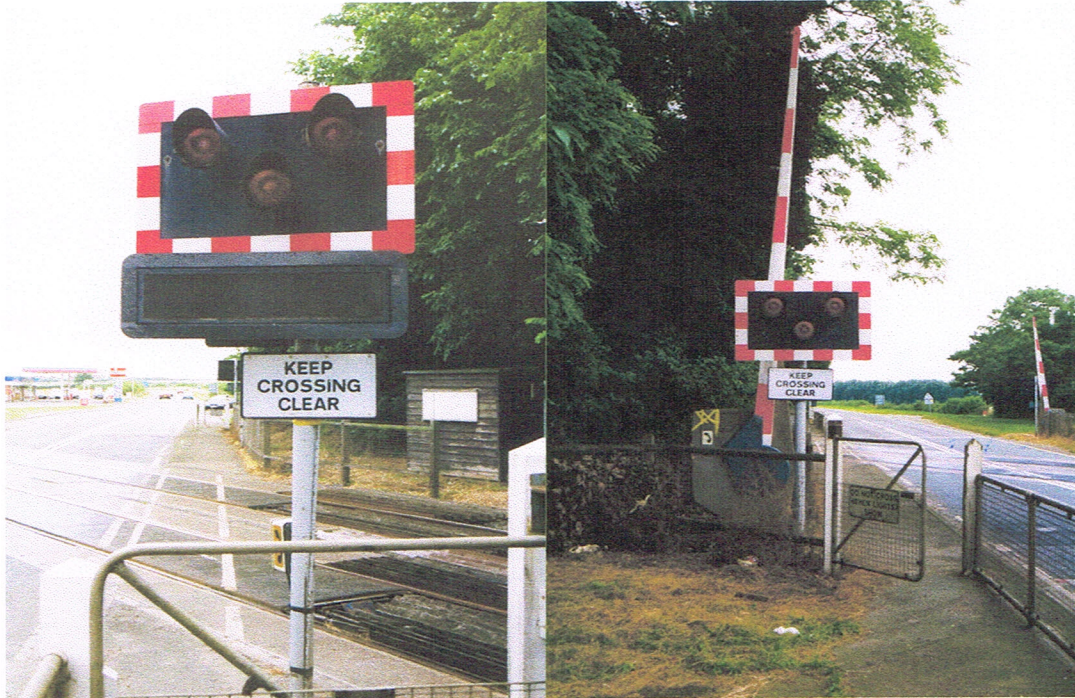
*Figure K.4*

*Quarrington AHB LC, Lincolnshire. Photographs from both sides of the LC on the same pavement.*

*Note the wicket gate that does not shut itself; the ATC sign that is not maintainable nor, more importantly, no longer shown in the Highway Code (the author noted 10 such LCs with this sign in Lincolnshire alone!); the phone unit held together by yellow tape.*

*Adjacent to the crossing is a mental hospital entrance/exit with vulnerable patients who possibly will not understand the significance of the wicket gate or level crossing.*

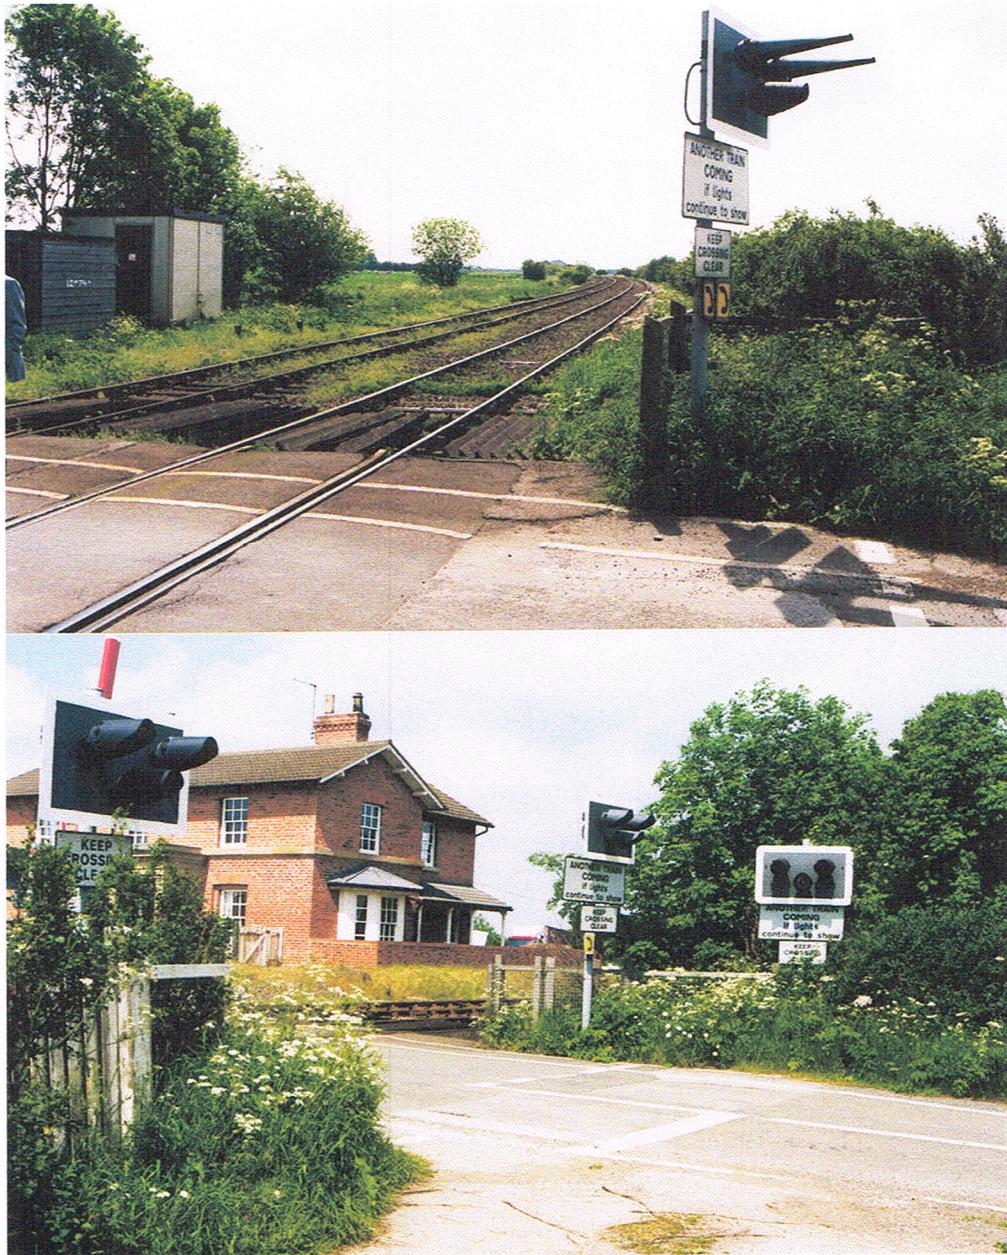
*Figure K.5*

*Lockington, AHB LC, East Yorkshire, 29.5.99.*

*Scruffy with a look of being not maintained very well. Road signals that do not have the red and white chequering as shown in SI 1519. The HMRI Inquiry report recommended closure of two of the four LCs in this vicinity; they are all still open. When are recommendations going to be acted upon for everyone's benefit ?*

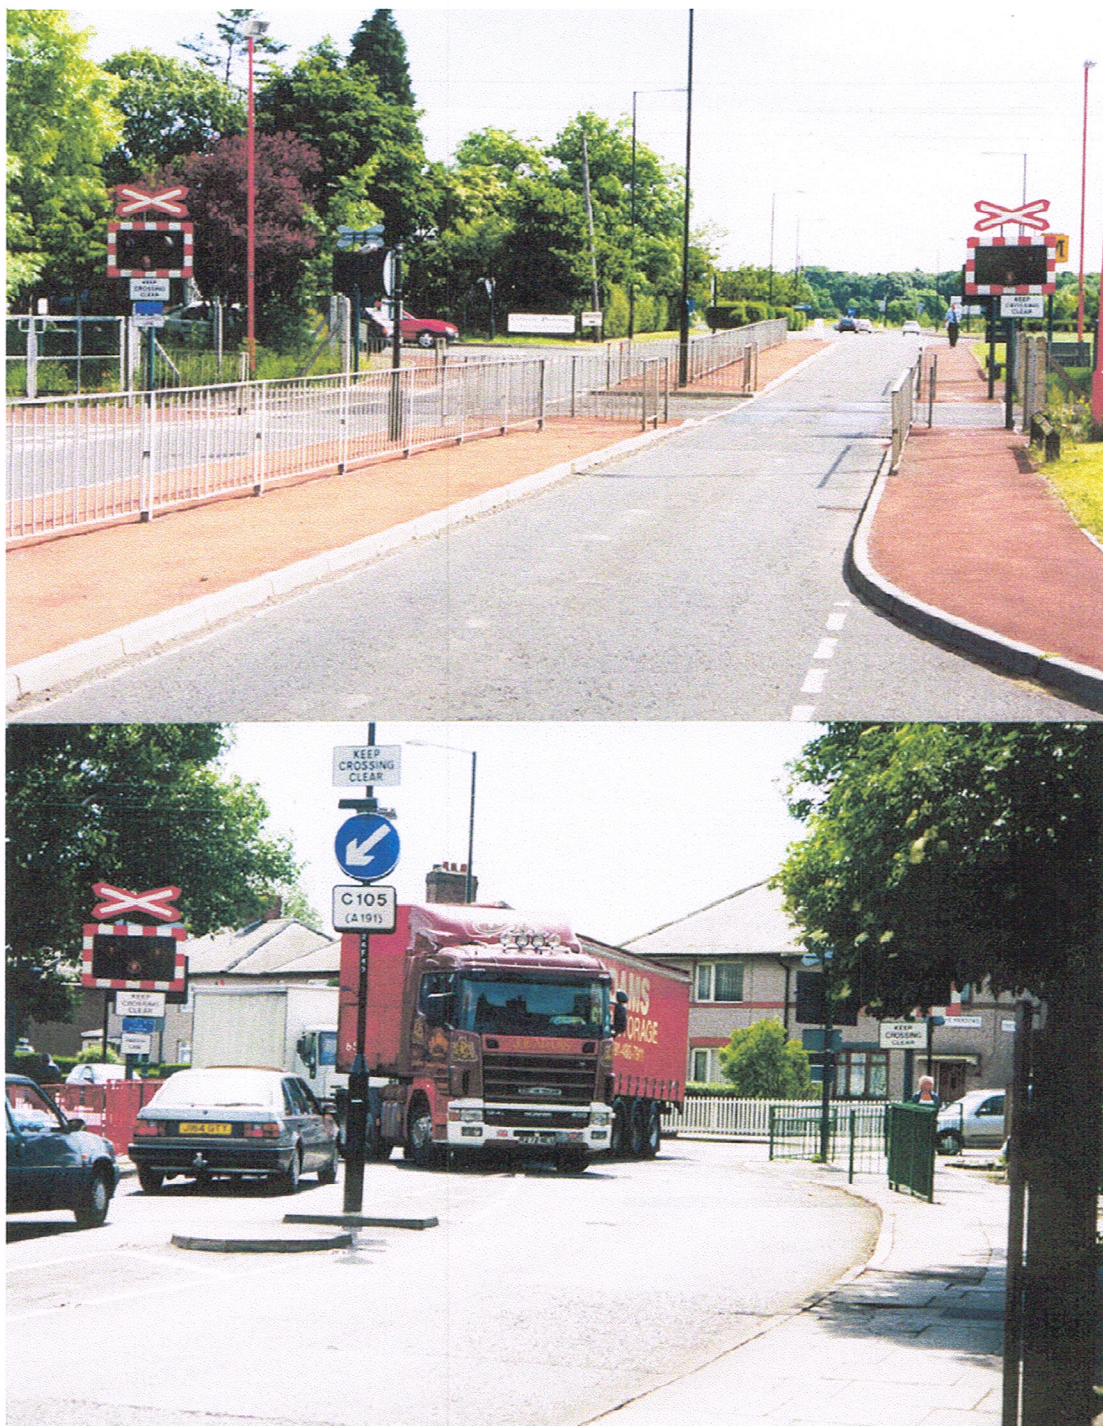
*Figure K.6*

*Callerton AOCL LC (top) and Fawdon AOCL LC (bottom), TMR;*

*Note the central reservation at Callerton to stop overtaking; At Fawdon the side turning is obviously causing problems for articulated lorries. The lorry driver is unlikely to hear the yodalarms nor be able to see the road signals when undertaking such a manoeuvre. See also figure 10.18.*

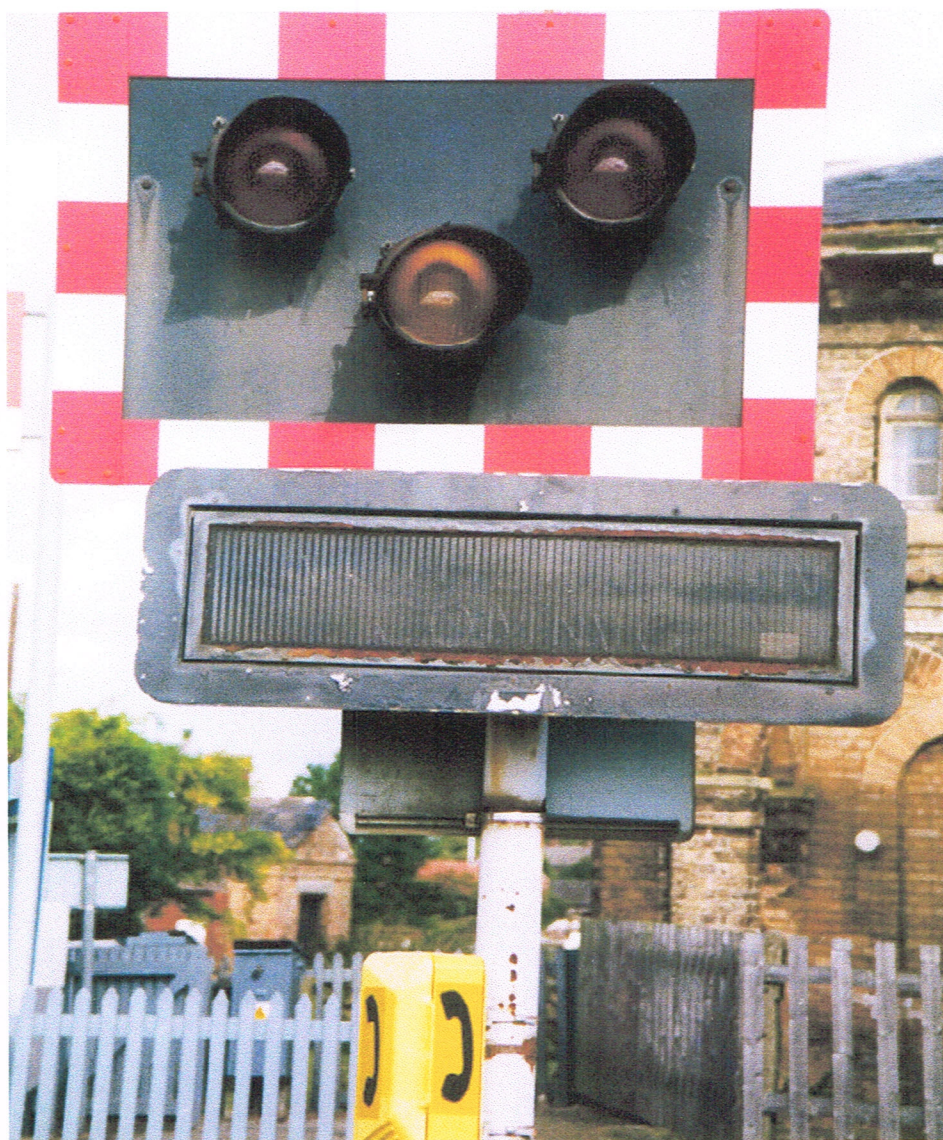
*Figure K.7*

*Collingham AHB LC, Lincolnshire;*

*The Another Train Coming sign, no longer shown in the Highway Code, not maintainable and probably not understood any longer by the public.*

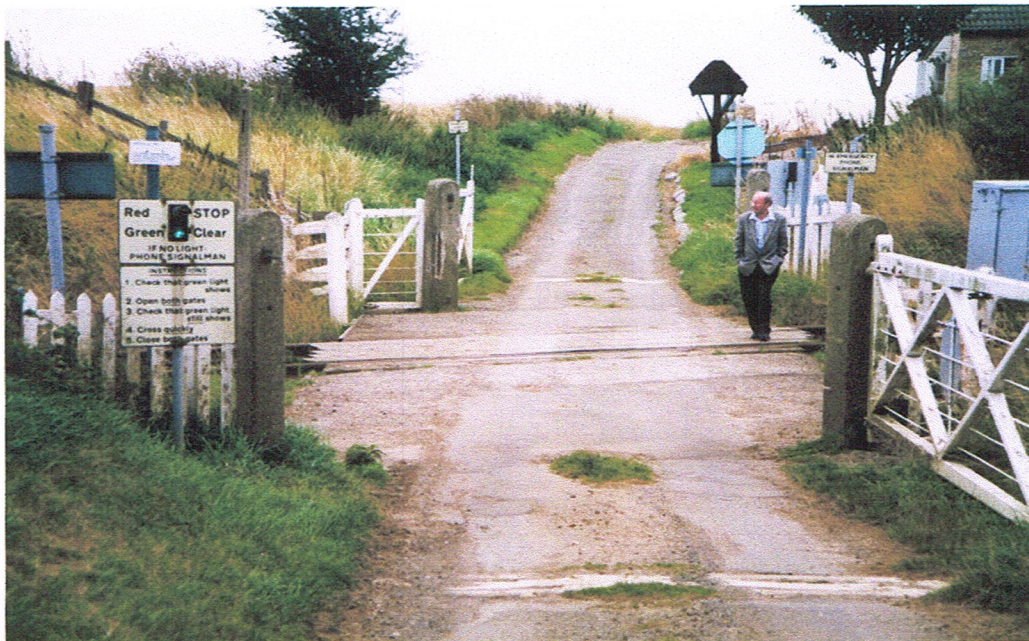
*Figure K.8 (top) & Figure K.9 (bottom)*

*Swinedyke MSLUWG LC, Lincolnshire (top) Robinson's Occupation Crossing, NIR (bottom); Gates left open by the last user, thus endangering future users, particularly youngsters who may not fully appreciate the dangers. Accommodation and Occupation crossings cause railways regular safety scares with such behaviour and farm vehicles etc. The fine for leaving gates open is £50 on NIR; It should be far higher and rigorously enforced by the courts.*

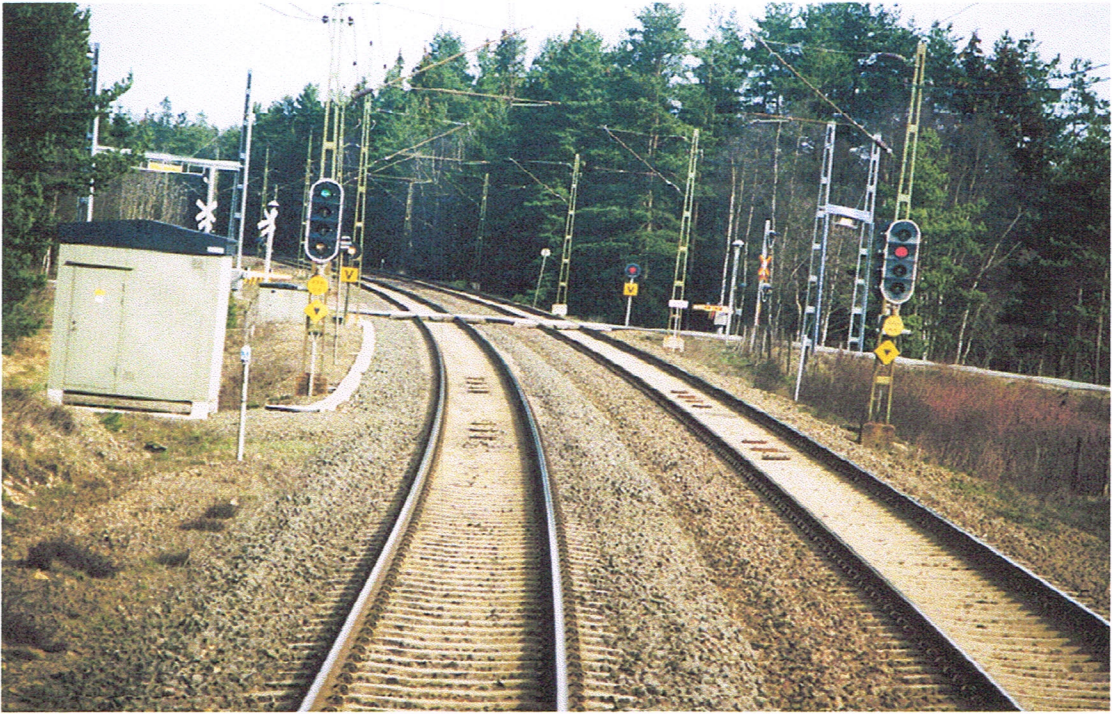
*Figure K.10*

*A train drivers view of a level crossing on the Malmo to Stockholm line.  
The tilting train is travelling at 200kmph and would not be able to stop in an emergency if  
something appeared on the level crossing in front of it.*

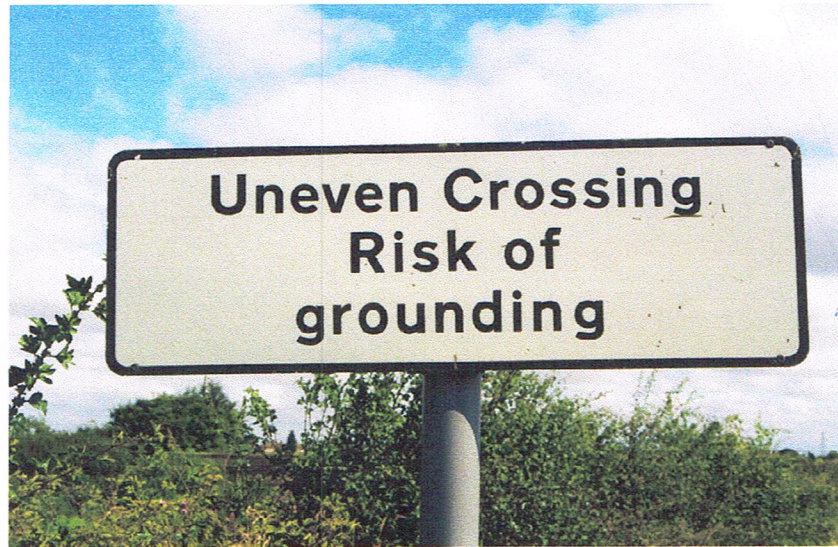
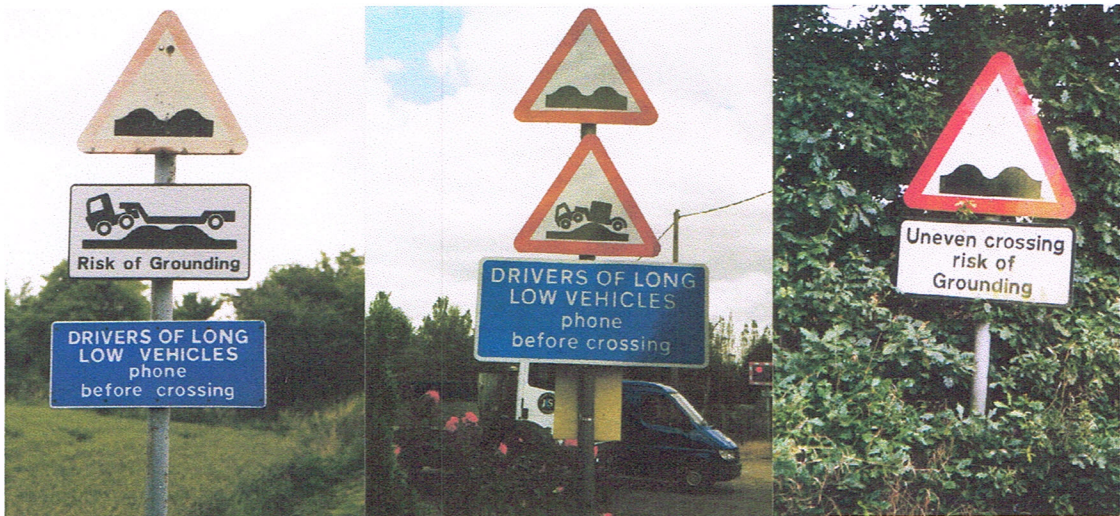
*Figure K.11*

*Confusion (1) !*

*Which is the current sign for a risk of grounding ?*

*Locations: (top) South Drove AHB LC, Lincs; (bottom) left to right, Stowgate 21 AHB LC, Lincs, Thorpe on the Hill AHB LC, Lincs, Loxley Lane AHB LC, Staffs.*

*The lower triangular sign at Thorpe on the Hill is the correct sign shown in SI 1519.*

*Highway authorities seem to be allowed an inordinate time to bring signs up to current standards.*

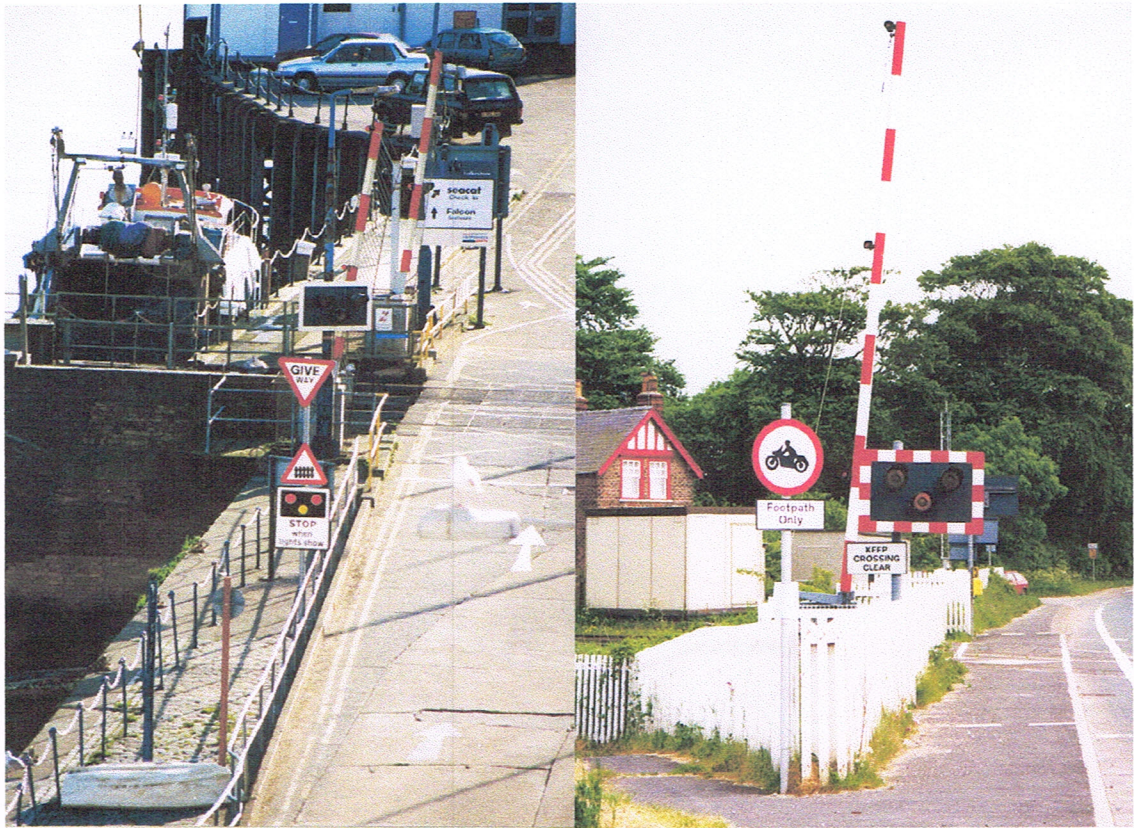
*Figure K.12*

*Confusion (2) !*

*Harbour MCB LC, Folkestone (left);*

*Showing two conflicting instructions on the same post; Stop when lights show and Give Way. Which does the motorist obey first ? The Give Way sign actually refers to a white line adjacent to the post which has been worn away by traffic.*

*Carnaby AHB LC, East Yorkshire (right);*

*Does the No Motorcycles sign refer to the left hand footpath or the one over the crossing ?*

*Why do we not have a common range of prohibition signs all with 45° red stripes ?*

*We go to great lengths to ensure that railway signals do not cause confusion but there are many instances of road signs and signals that no such consideration has been given to.*

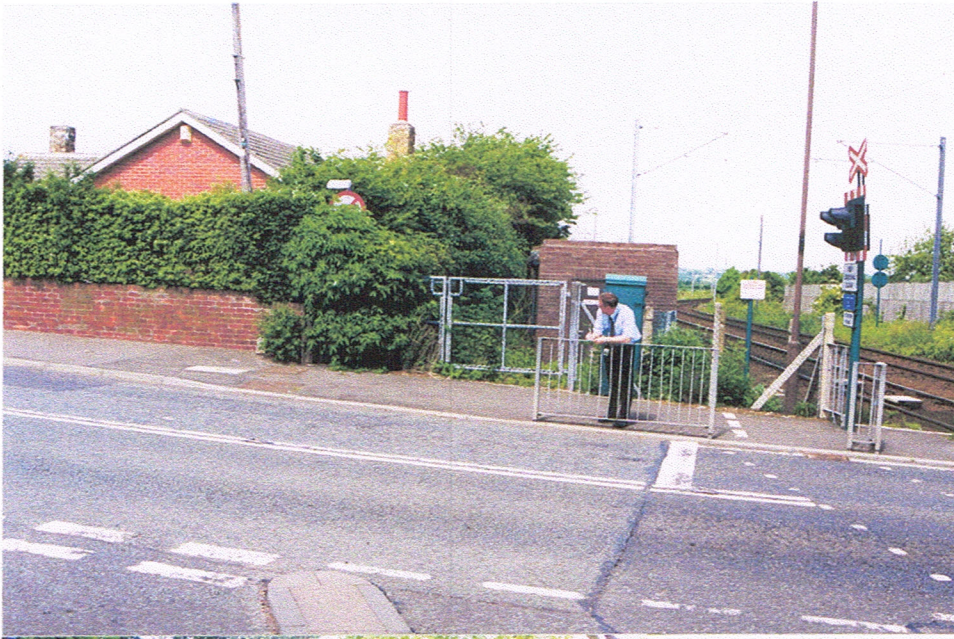
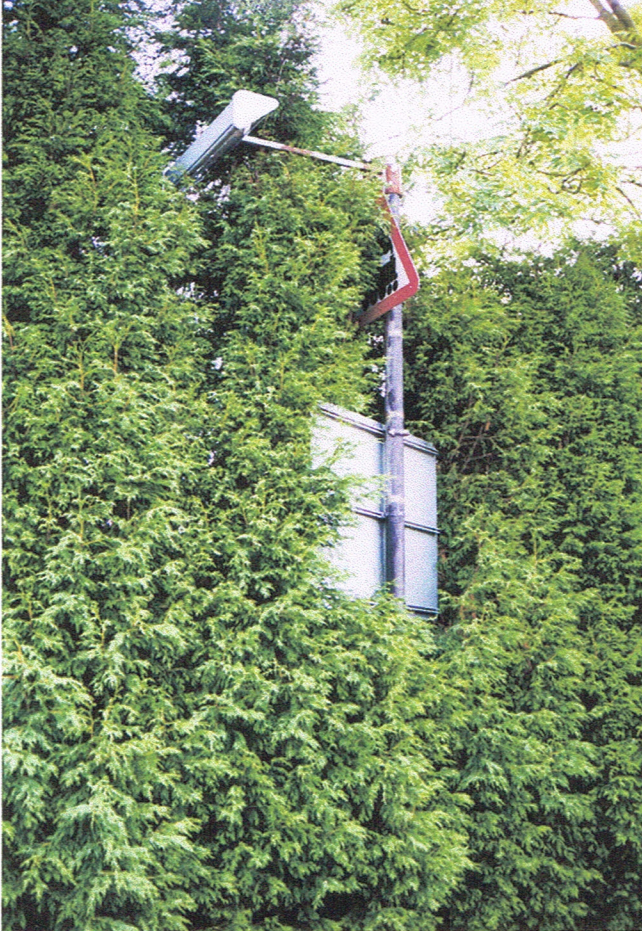
*Figure K.13  
Bank Foot AOCL LC (top), and  
Callerton AOCL LC (lh side), TMR;  
England is a green and pleasant  
land.....  
particularly when it comes to obscuring  
vital road signs with vegetation.*

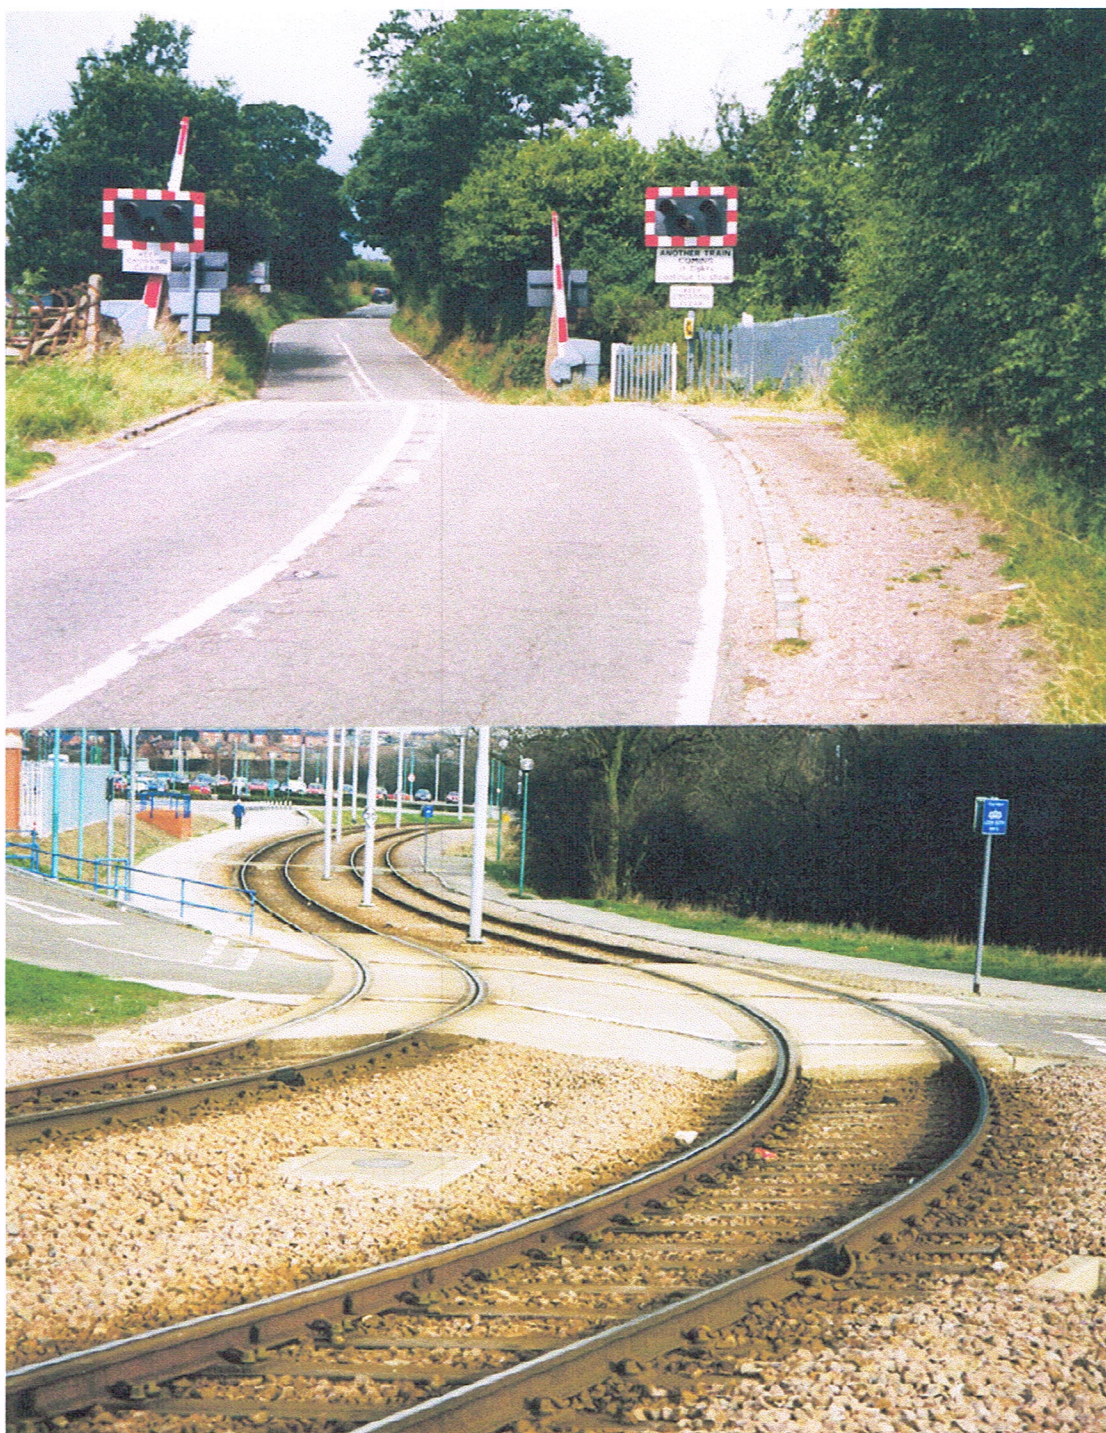
*Figure K.14*

*Loxley Lane AHB LC (top) and Crystal Peaks OC, Sheffield Supertram (bottom); Graphically showing the risk of grounding and why the road surfaces need to be as level as possible; no risk of grounding signs noted in Sheffield. Loxley Lane is on a steep hill with only the LC road surface level, the rest is on a 1 in 8 slope or so.*

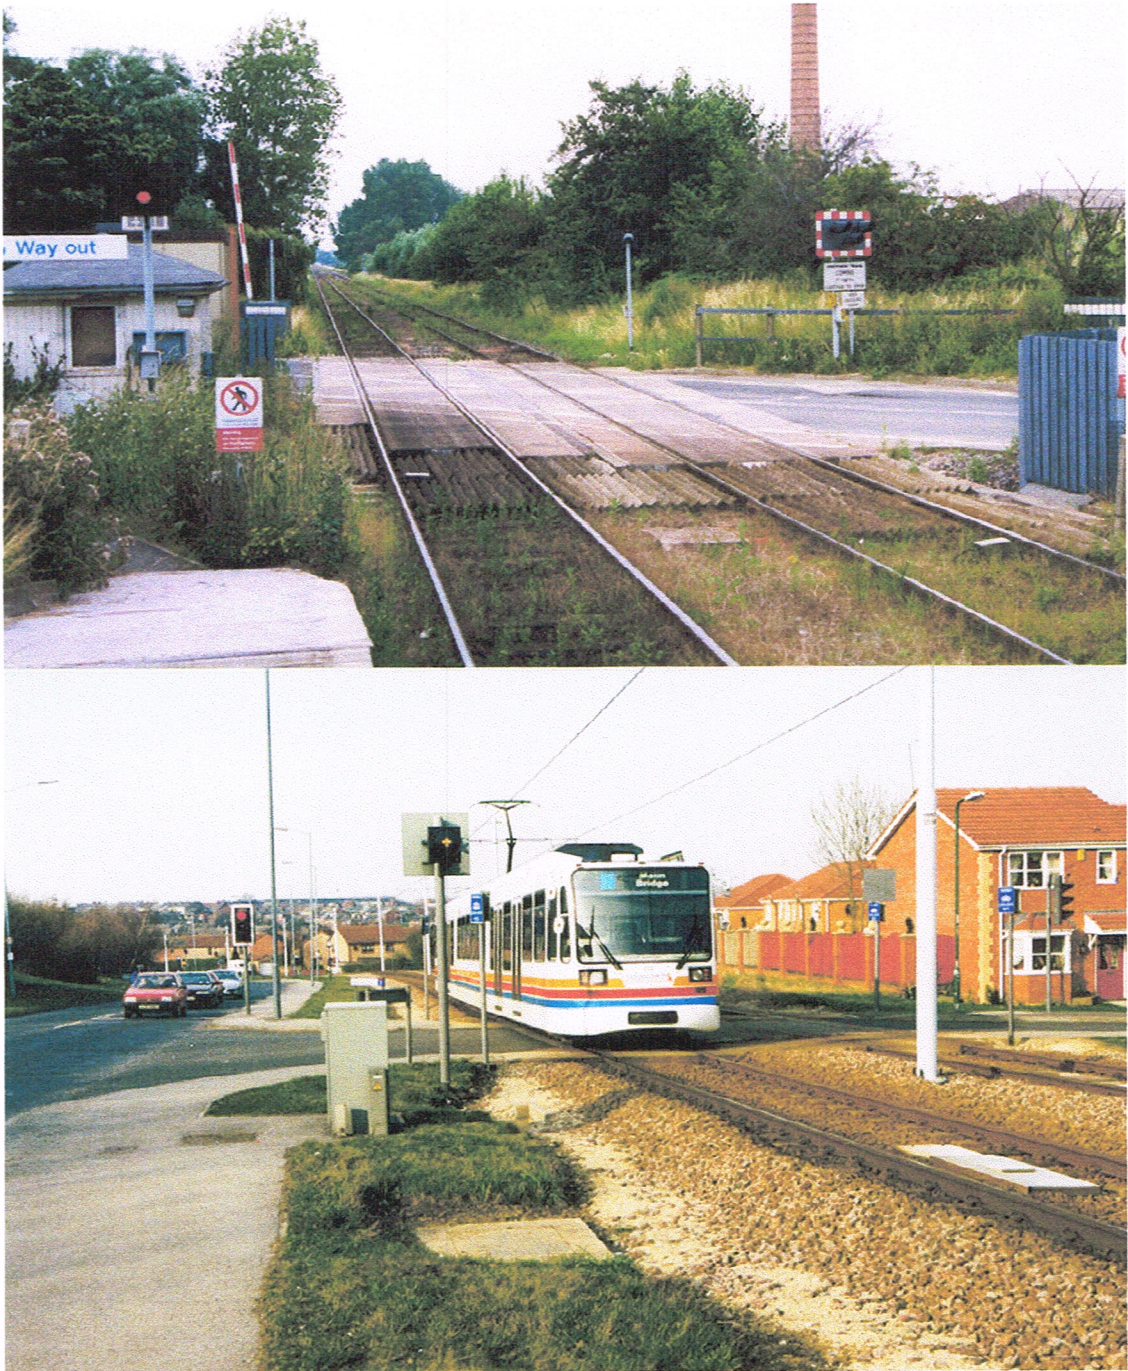
**Figure K.15**

***Kempston Hardwick ABCL LC, Beds, (top) and Waterthorpe, SS (bottom);***

***We now have trams running in several places in the UK; The author fails to understand why a Sheffield tram on segregated track weighing 53 tons and capable of 50mph needs less protection, e.g. conventional traffic lights, no fencing, than a single car DMU on a rural railway weighing 35 tons and travelling at 40-50mph (although capable of 75mph) which requires an AHB, AOCL or ABCL and with traffic levels in some places minute compared to that in Sheffield.***

***It appears to be another legislative inconsistency.***

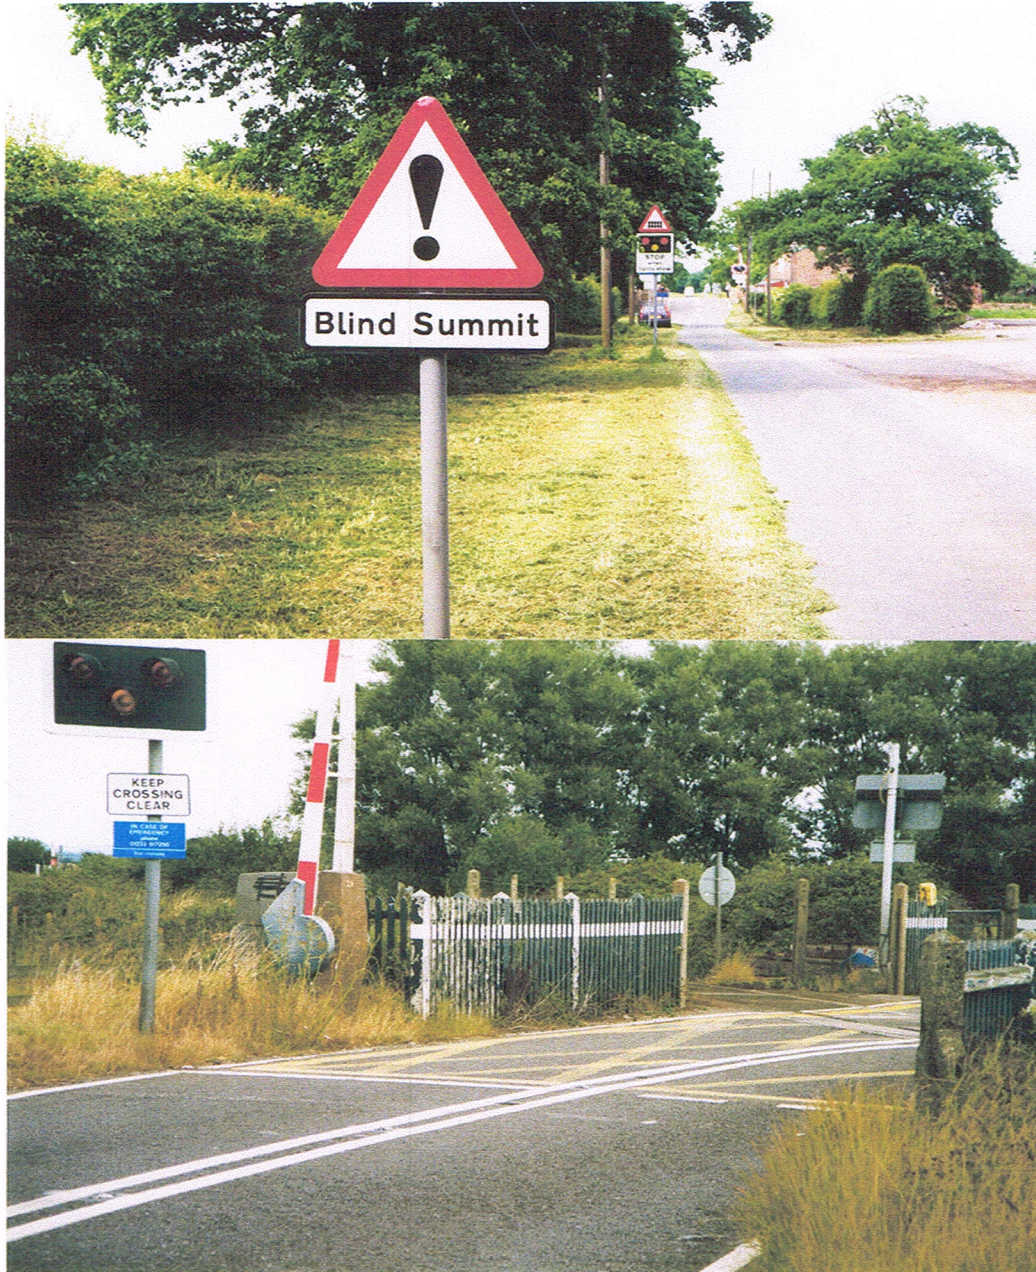
*Figure K.16*

*Rowland Hall AHB LC, East Yorks (top) and Star AHB LC, Sussex (bottom); Rowland Hall is displaying an additional sign indicating the blind summit on the LC, effectively a 'hump back bridge' effect; The fencing at Star has been additionally painted with a white stripe to emphasise the roadway and warn motorists not to turn left down the track. (See the comments in Chapter 4 relating to Upper Denton LC in Cumbria)*

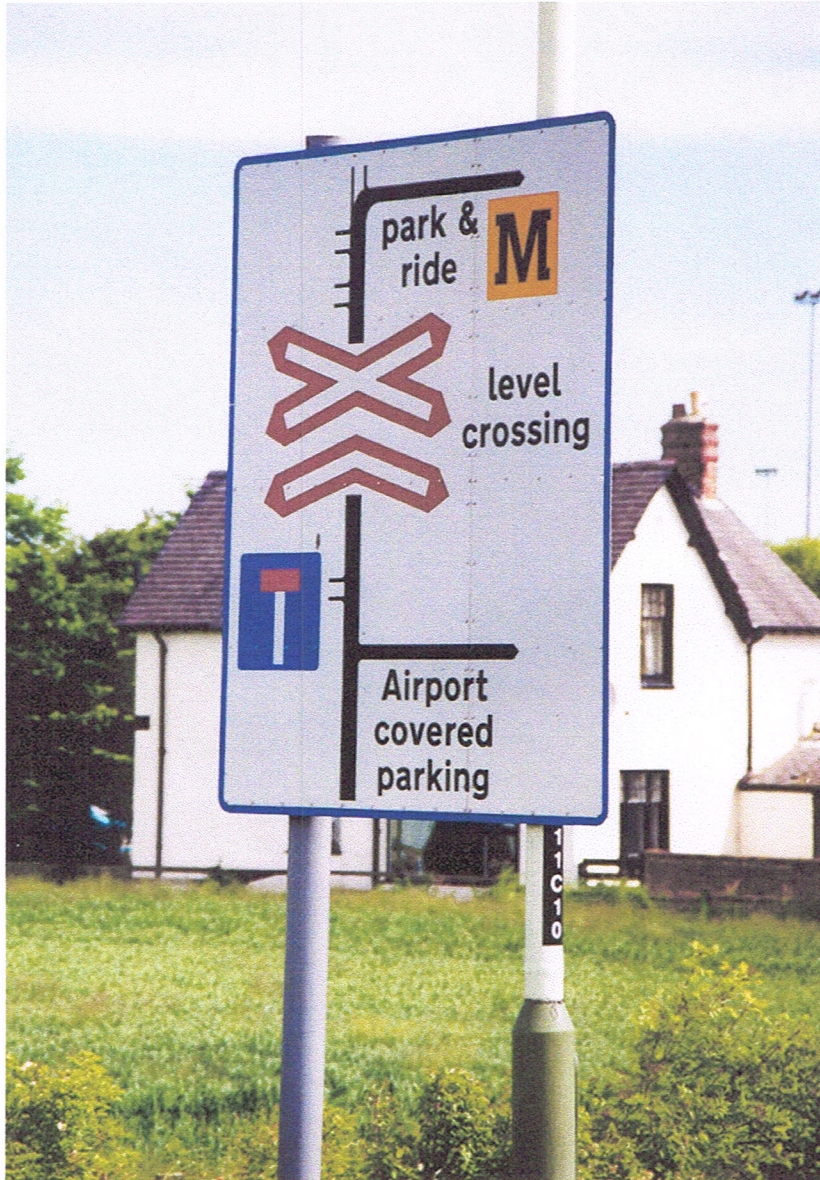
*Figure K.17*

*Callerton AOCL LC, TMR;*

*Note the additional St Andrews Cross on the road sign to give further warning, the second track symbol is now illegal.*

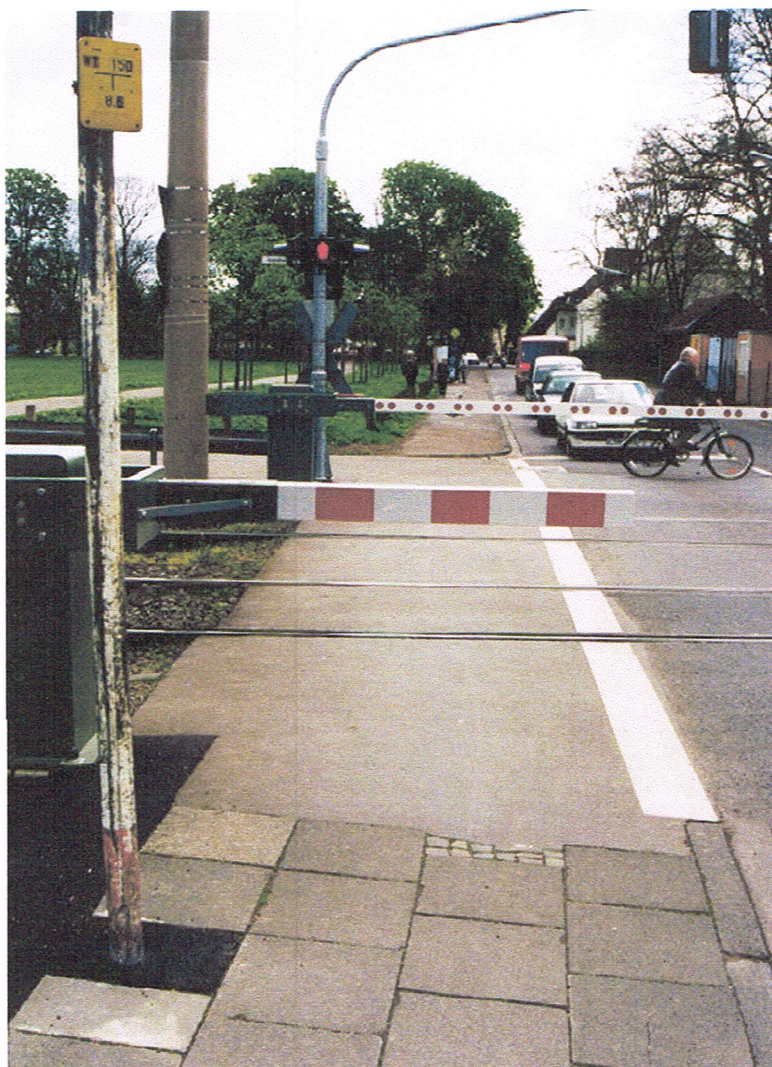
*Figure K.18*

*An AHB LC on the Cologne Tramway system in Germany;*

*Note the additional small barrier to stop pedestrians and the flashing red man signal on the opposite side so that it is in view of the pedestrian.*

*One anomaly in the UK Highway Code apparent in rural areas, is the lack of any barrier to prevent pedestrians walking onto the LC if they are obeying the Highway Code and walking facing oncoming traffic; if the person is deaf or has a sight problem they may not hear yodalarm or see the road lights and could thus walk into the side of the approaching train.*

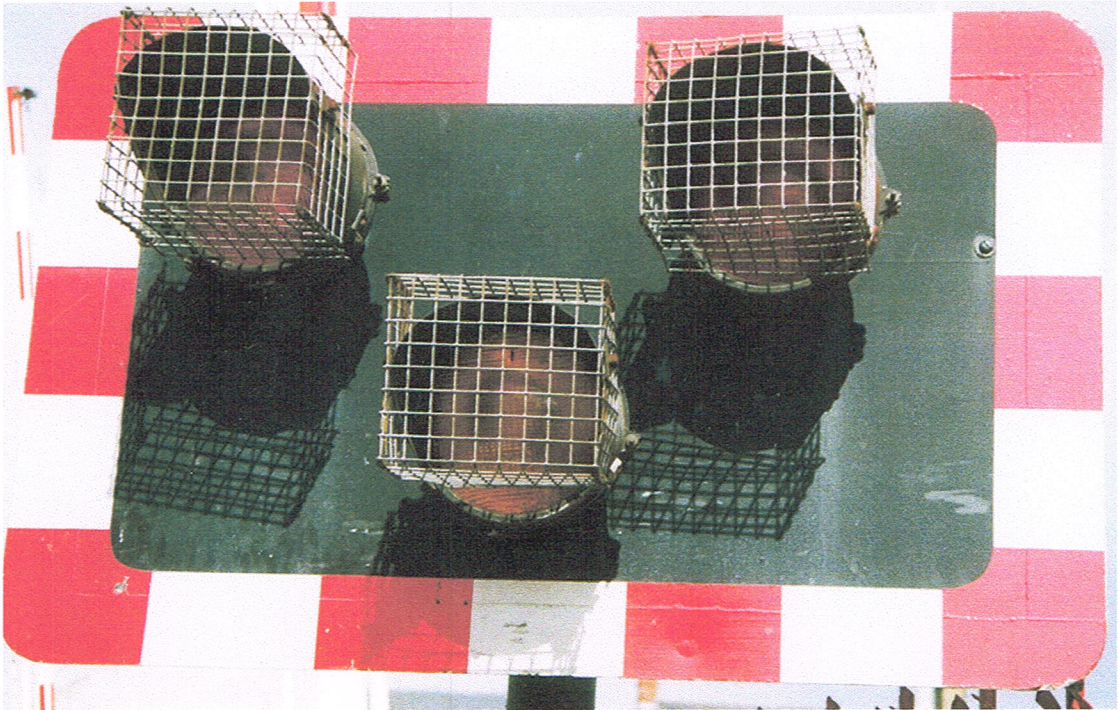
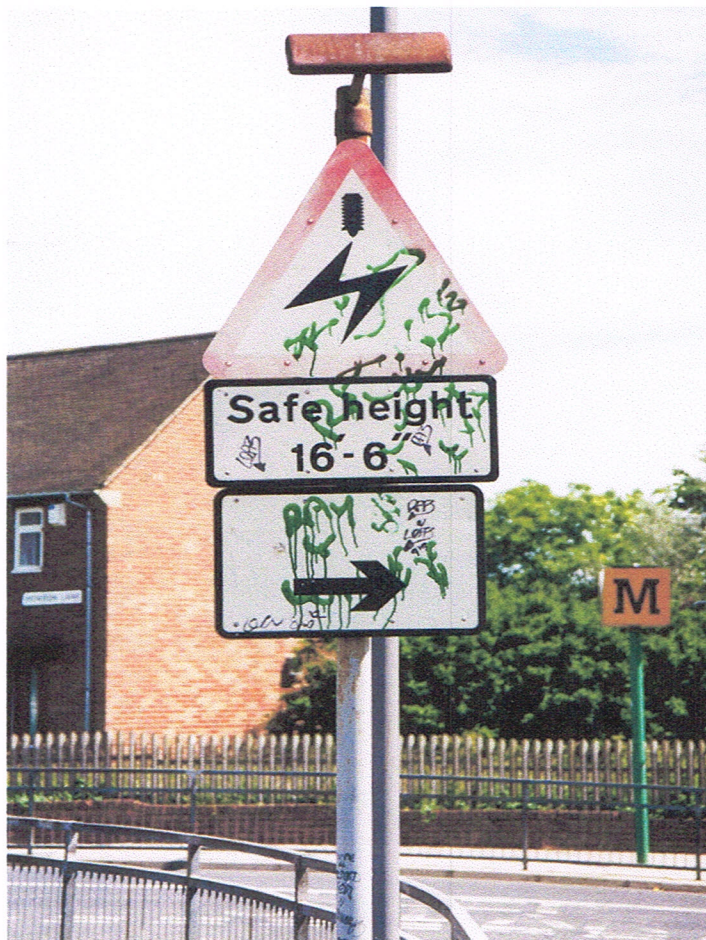
*Figure K.19  
William Street MCB LC, Lurgan,  
NIR, County Armagh (top) and  
Howden AOCL LC, TMR  
(lh side);  
Vandals are a problem in a lot of  
places and are a sad reflection on  
life in the '90s. In Northern  
Ireland and particularly in the  
Lurgan and Portadown areas  
special measures are needed.*
