**Appendix K**  
**Other Level Crossing and**  
**Road Rail Interface Issues**  
Photographic Evidence

### K.1 Introduction

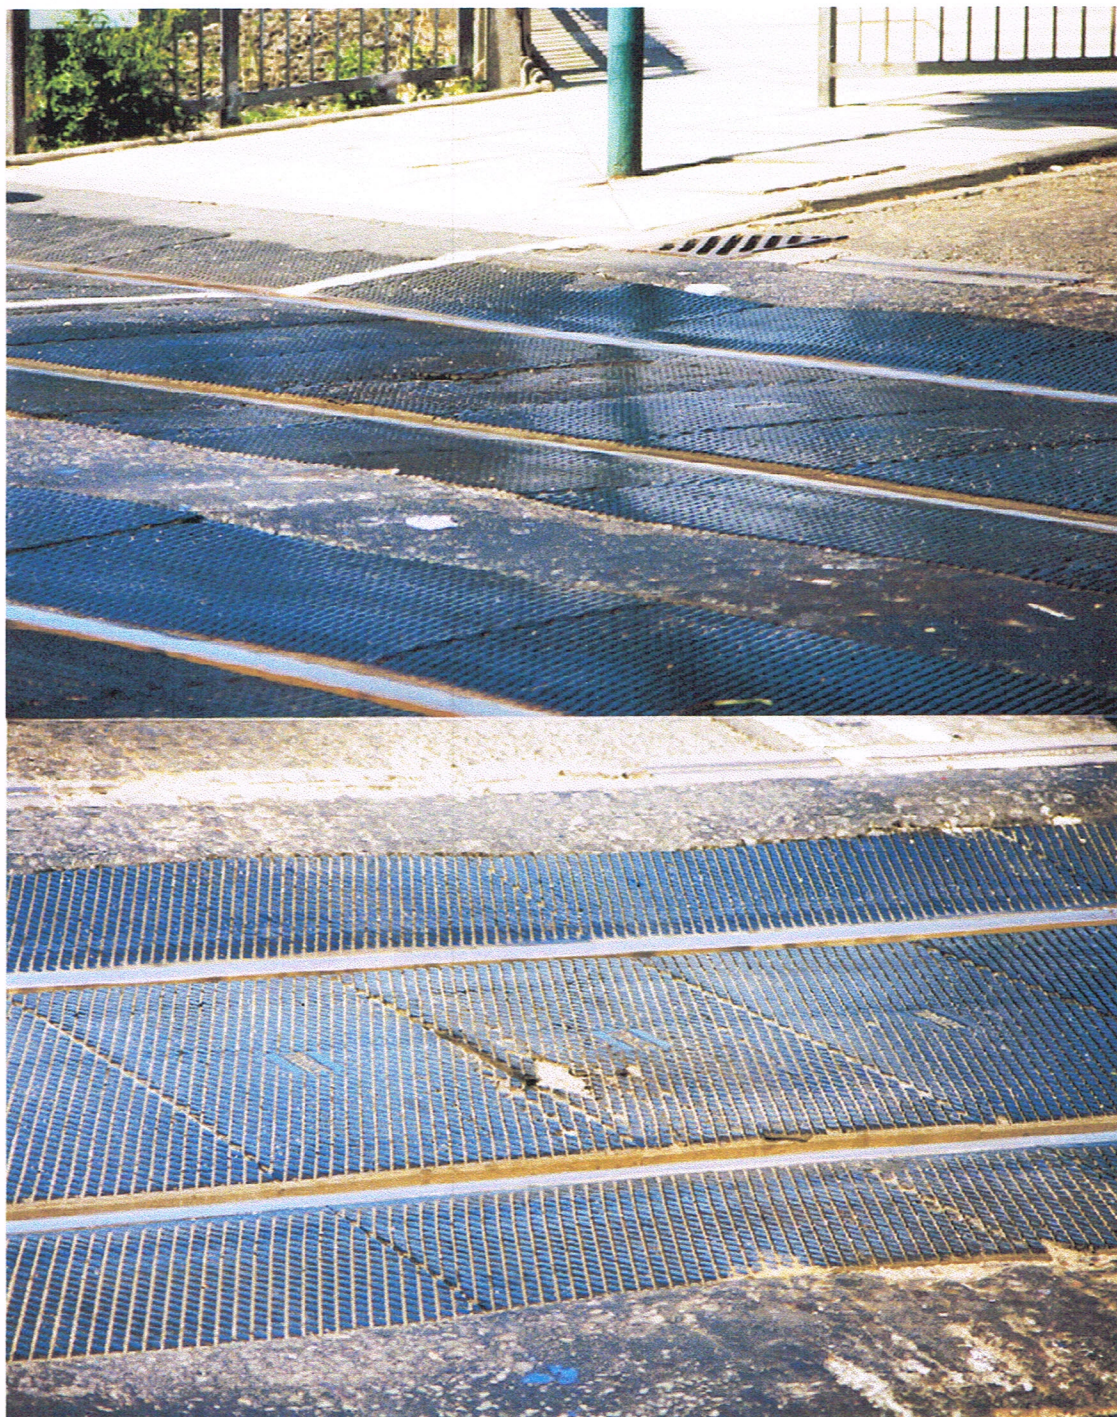
*Figure K.20*

*Howden AOCL LC, TMR;*

*Note how the road surface suddenly changes to an upward slope in the top picture; note also the damage vehicles are doing to the LC decking (Strail panels) and the concrete; this indicates that numerous vehicles are scraping the road with a subsequent risk of grounding*

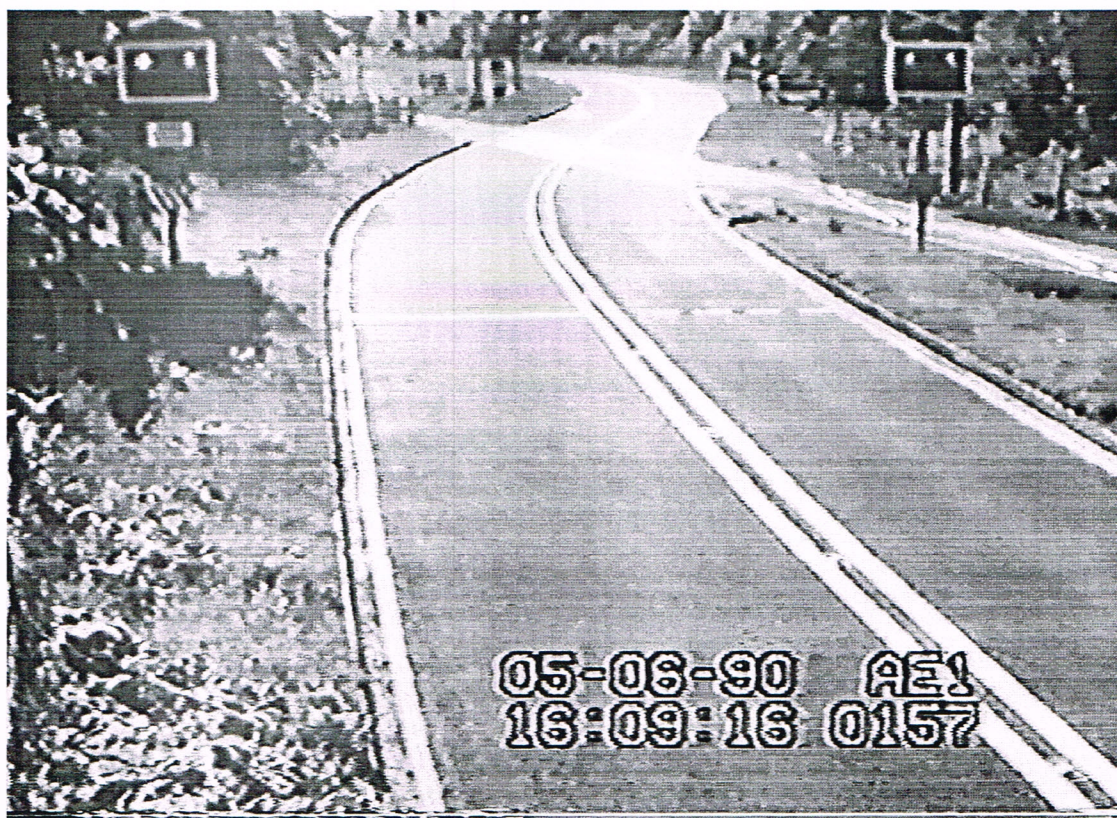
*Figure K.21*

*Umbra AOCL LC, NIR;*

*9 seconds into sequence, note red lights are clearly working.*

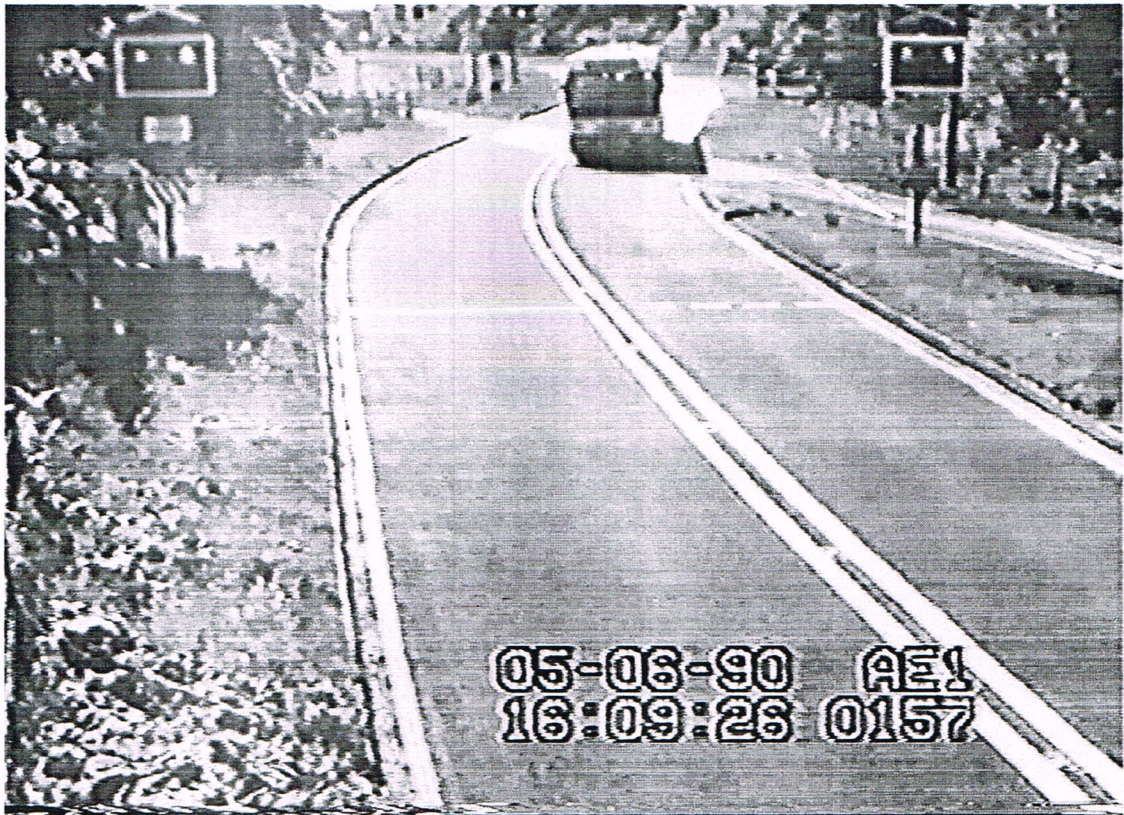
*Figure K.22*

*Umbra AOCL LC, NIR;*

*19 seconds into sequence, note red lights are clearly working.*

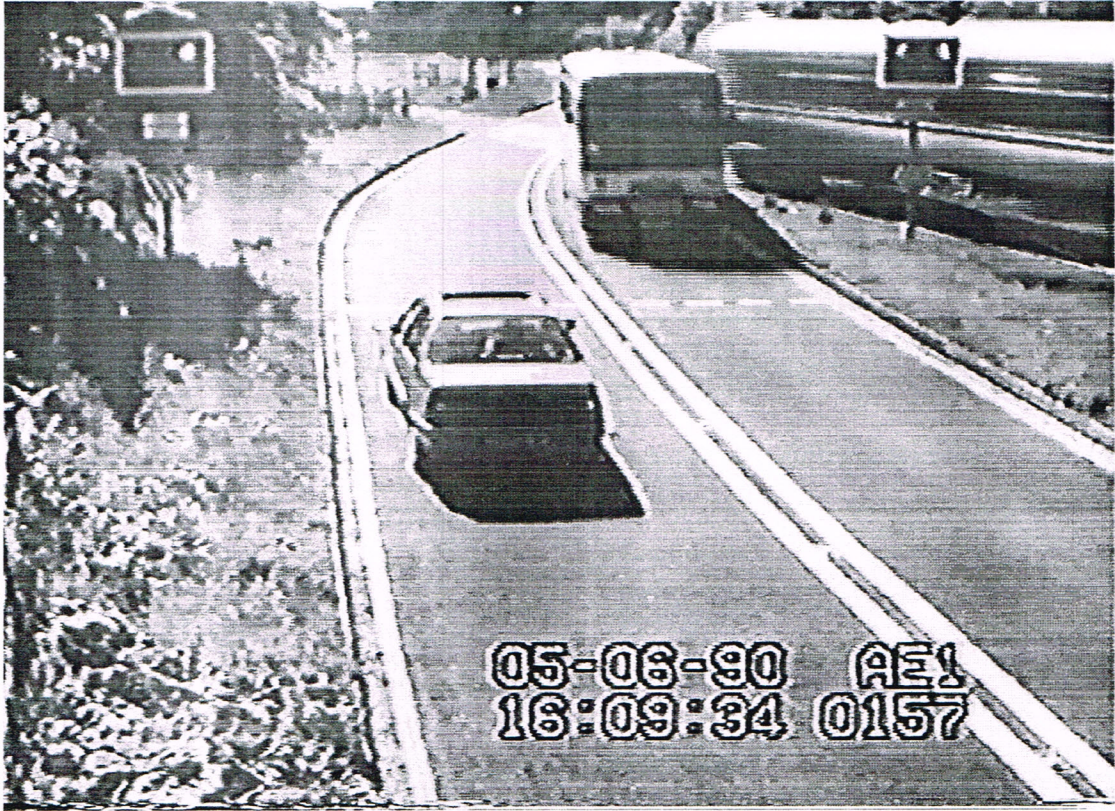
*Figure K.23*

*Umbra AOCL LC, NIR;*

*27 seconds into sequence, note red lights are clearly working; the second bus!*

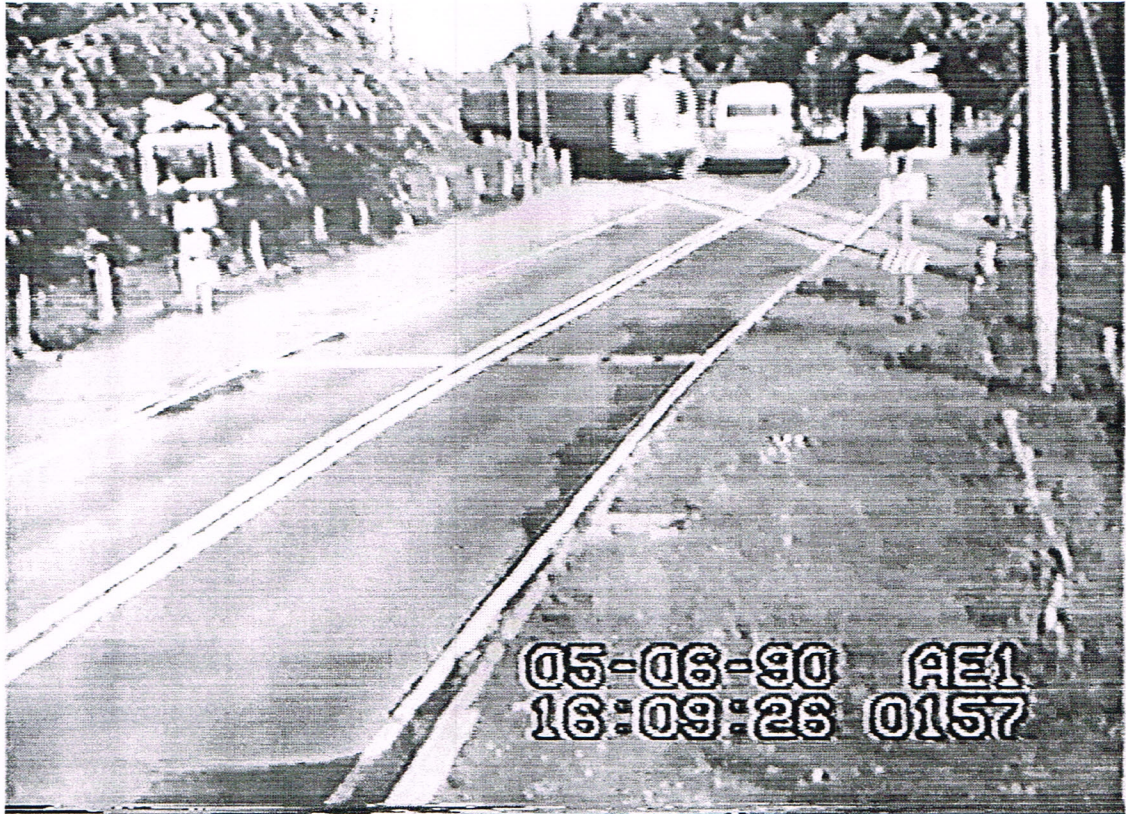
*Figure K.24*

*Umbra AOCL LC, NIR;*

*27 seconds into sequence, note red lights are clearly working; the second bus!  
(from the other side of the crossing)*
