Other Level Crossing and Road Rail Interface Issues

10.0 Introduction

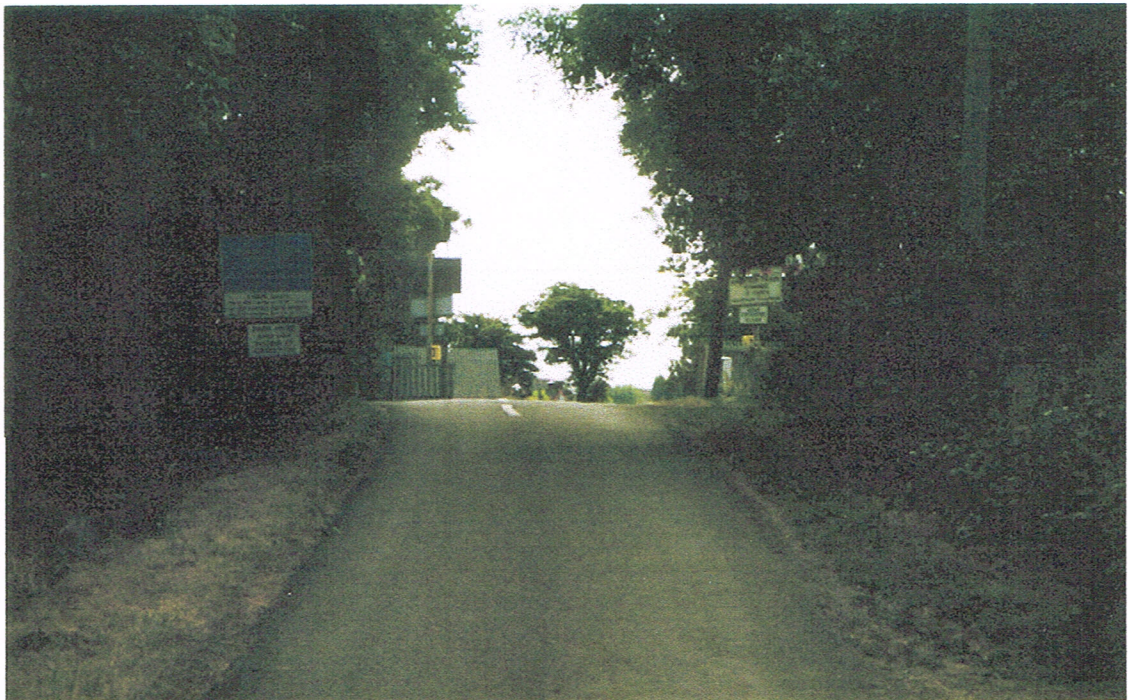
Figure 10.1

At South Scarle AHB LC, in rural Lincolnshire, the author discovered a classic level crossing problem. Looking in a north-westerly direction, the level crossing has excellent signposting, and the barriers and road traffic lights are visible from a fair distance. However, when looking in a south-easterly direction, from the other side of the level crossing, it becomes a highly dangerous interface to the railway, with the motorist being 'blinded' by the mid-morning sun. The signposts, road signals and level crossing have blended into the vegetation in the surrounding area.

South Scarle AHB LC, Lincolnshire, looking south-east. If your eyesight is good you may just make out the red and white backboard chequering of the road signals facing the motorist!

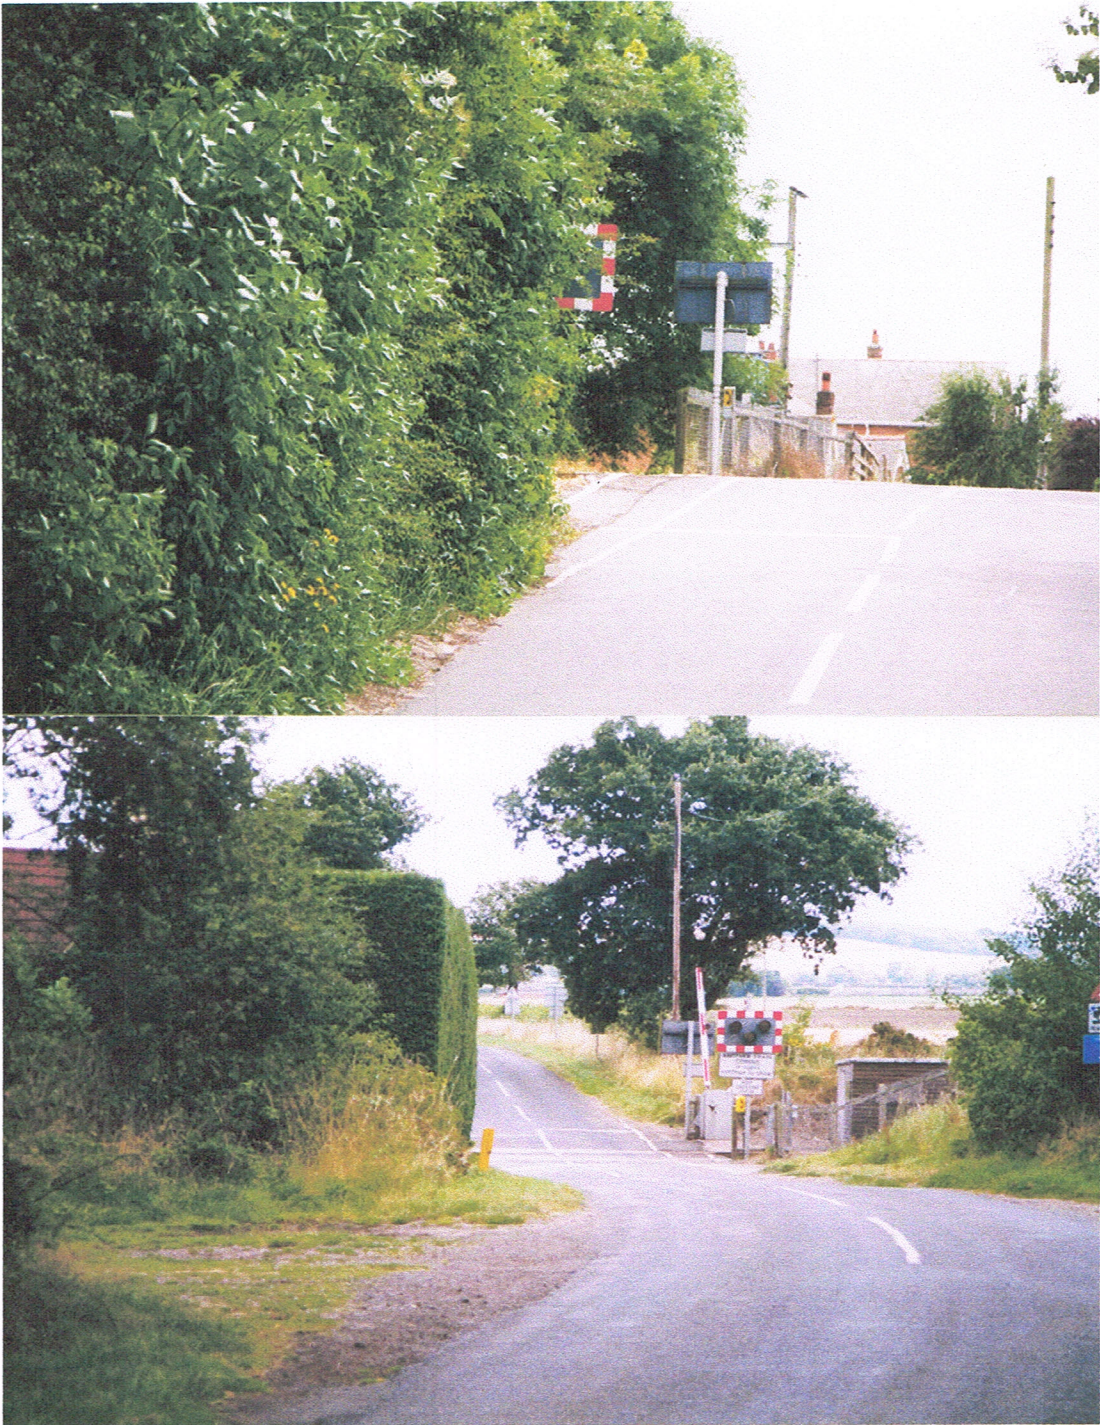
Figure 10.2

Many level crossings were seen with excessive vegetation obstructing signage and road traffic signals. At several locations, the primary road traffic signal was completely obscured to the approaching driver as a result of the hedges on the left hand side of the road. If a high sided vehicle is passing at the right moment the secondary signal will also be obscured putting the approaching driver in an unfortunate and dangerous position. (see figure 10.2).

Willoughby Road AHB LC (top) and Walesby AHB LC (bottom) both Lincolnshire; In both cases the primary road signal is totally obscured to the approaching driver as a result of the hedges on the left hand side of the road. If a high sided vehicle is passing at the right moment the secondary signal will also be obscured putting the approaching driver in an unfortunate and dangerous position.

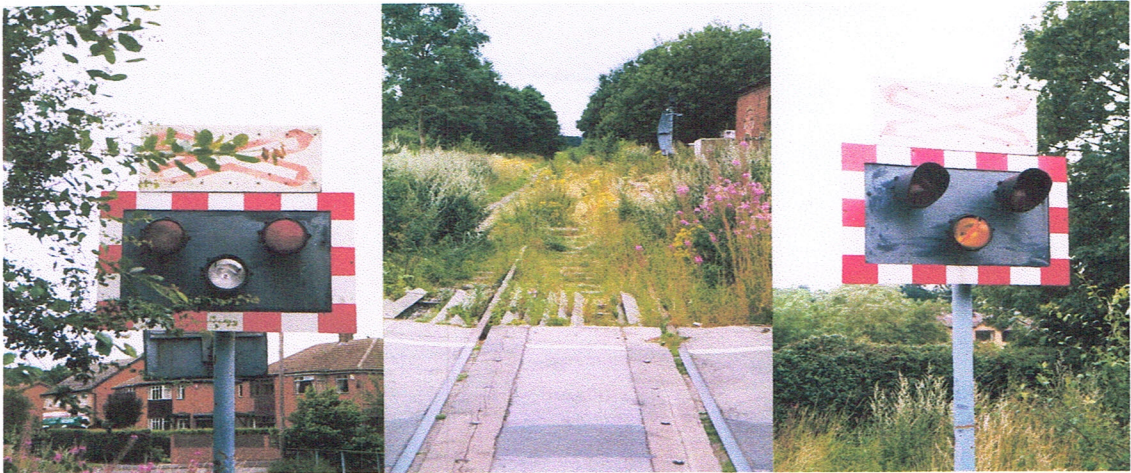
Figure 10.3

Endon AOCL LC, Staffordshire; the railway line is shown in Quail as being 'not in regular use'. If the line is still open the LC should be maintained properly and not allowed to deteriorate.

The public will not treat the LC seriously when left in such a state.

If the railway has been mothballed, then the level crossing should also be, so that the public does not treat it with complacency.

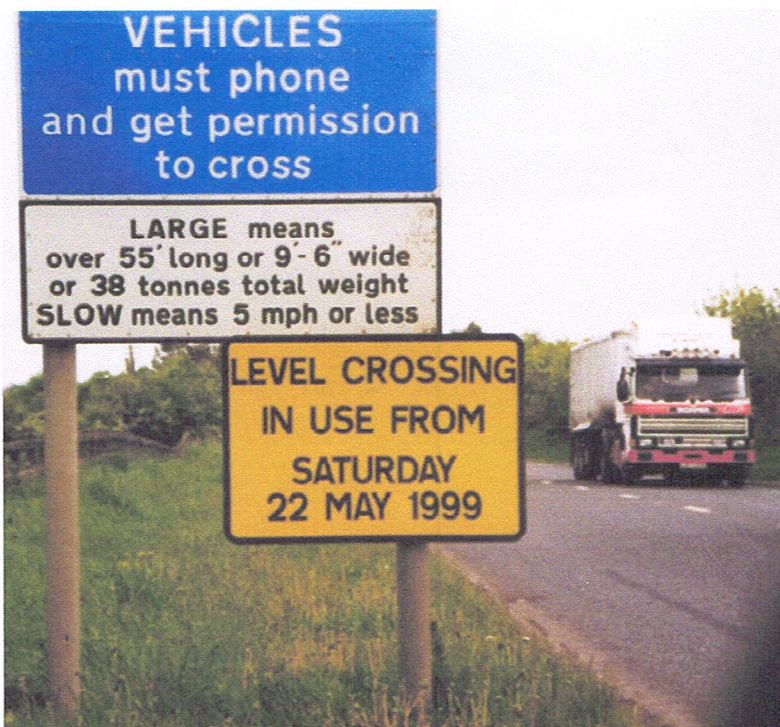
Figure 10.4

*Kilmakee AHB LC,
Co. Antrim;*

The level crossing and railway have been out of use for a considerable time; new train services require additional warning signs.

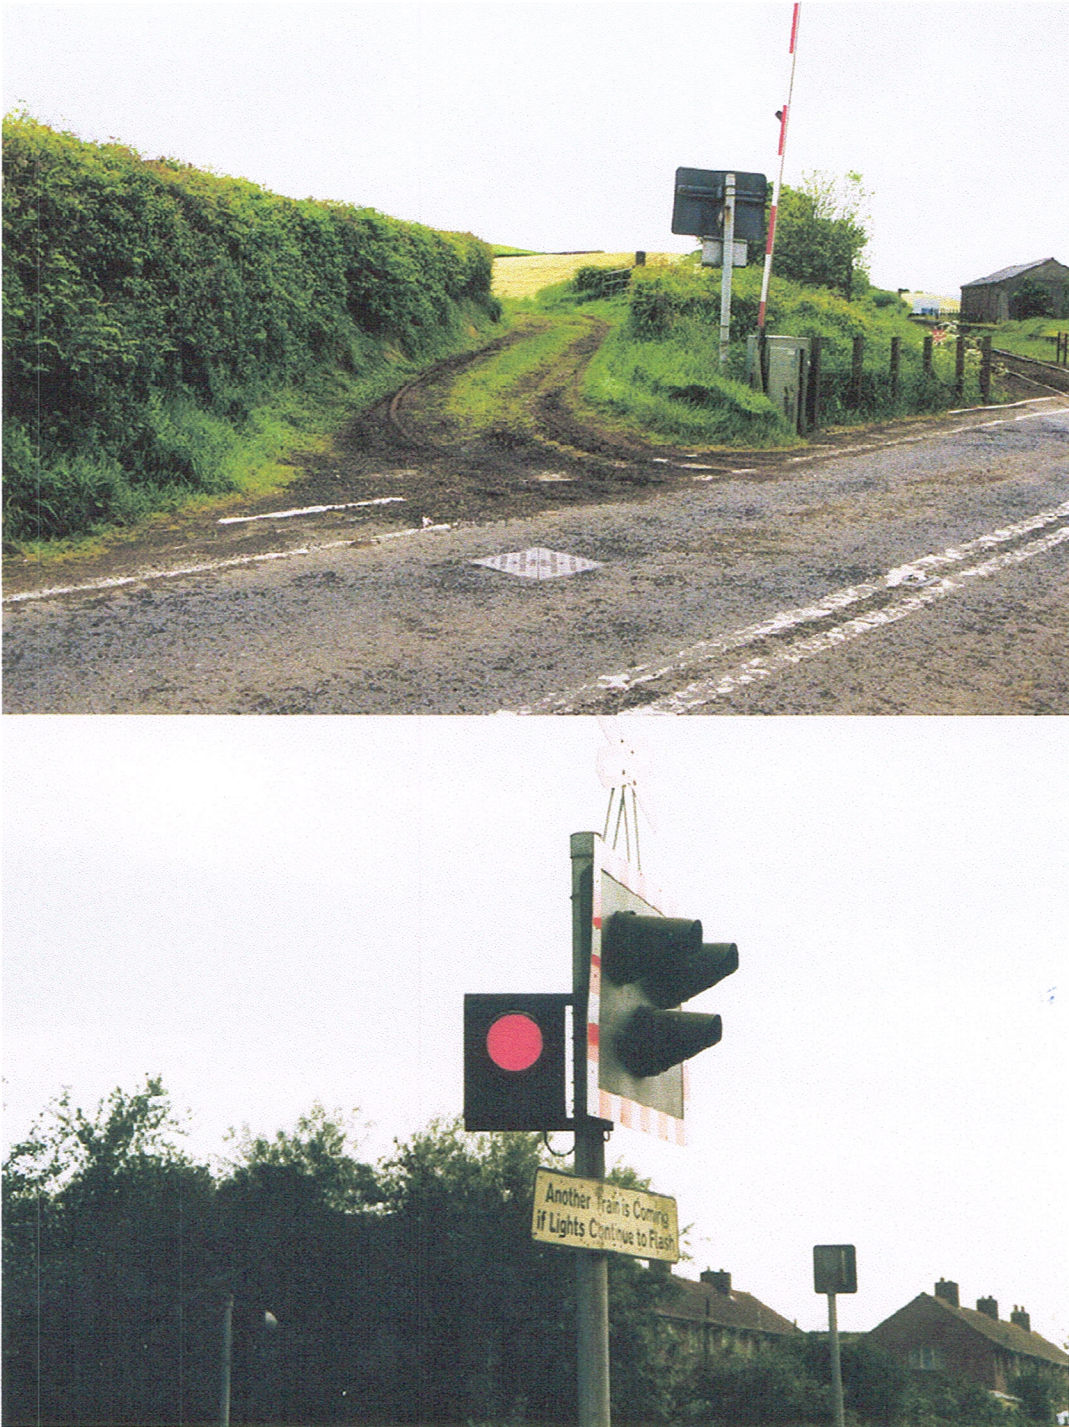
Figure 10.5

Killagan AHB LC, NIR, County Antrim (top) and Dymchurch West AOCL, RHDR, Kent (bottom); Side roads are always a problem to the level crossing designer and cause additional dangers to the railway; The farm track at Killagan may only be used several times a year, but the traffic is crossing the railway as evidenced by the mud trails. Note full size road traffic signal; The RHDR has installed a single additional red flashing light to warn those in the side entrance, a novel method of advising those users.

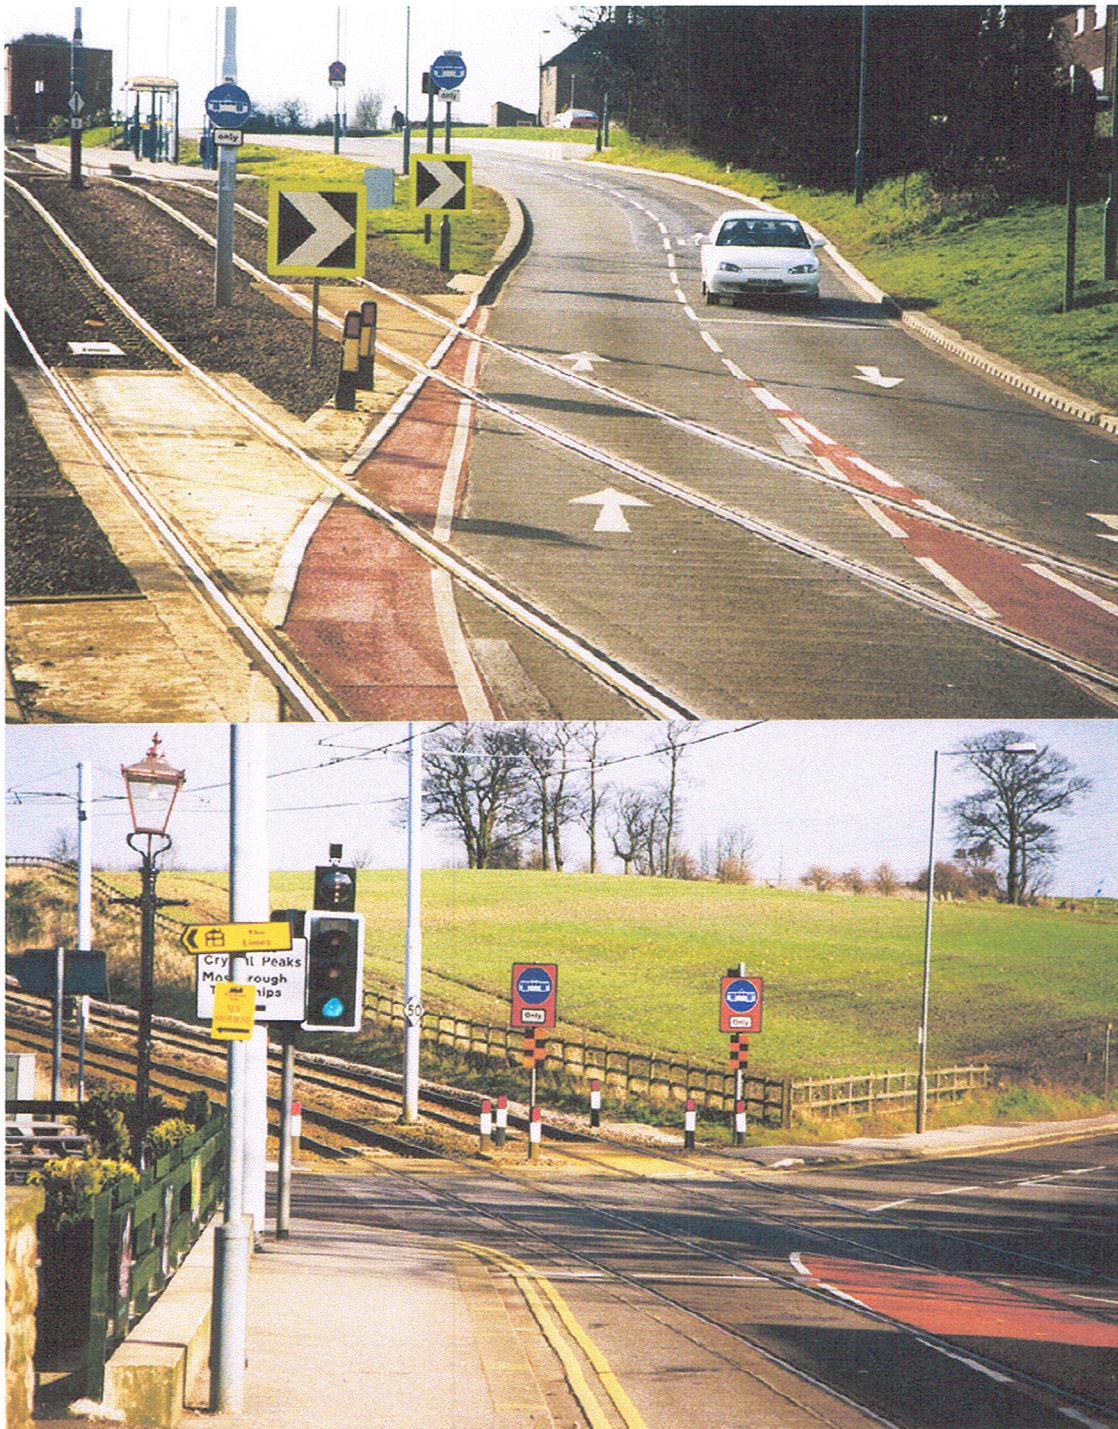
Figure 10.6

Birley Lane (top) and White End Lane (bottom); Sheffield Supertram.

Sheffield Supertram has discovered a new and worrying problem, which is likely to become more commonplace as tramways and LRV systems are reintroduced. They have had a number of accidents where motorists have ended up on the segregated track, presumably caused by motorists 'tailgating' the tram and following the rails instead of the white lines; note the additional signs and road markings to give further warning to those concerned (See Figure 10.6).

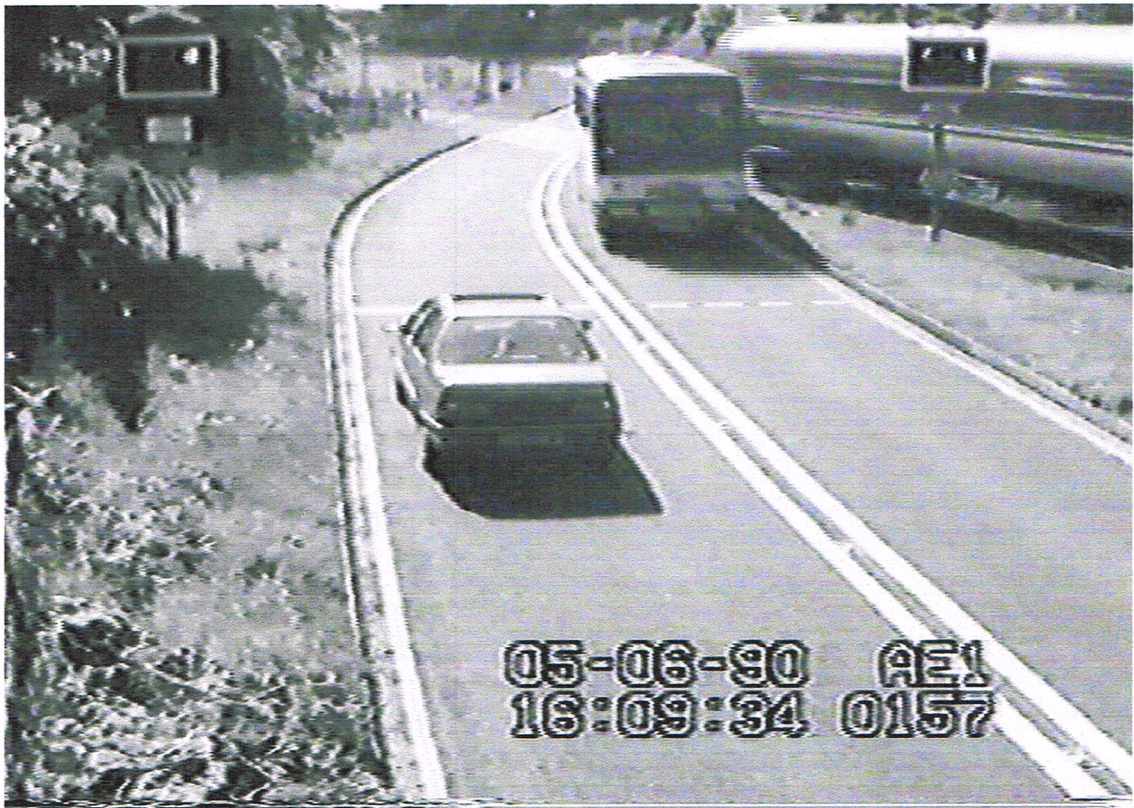
Figure 10.7

Umbra AOCL LC, NIR;

27 seconds into sequence, note red lights are clearly working.

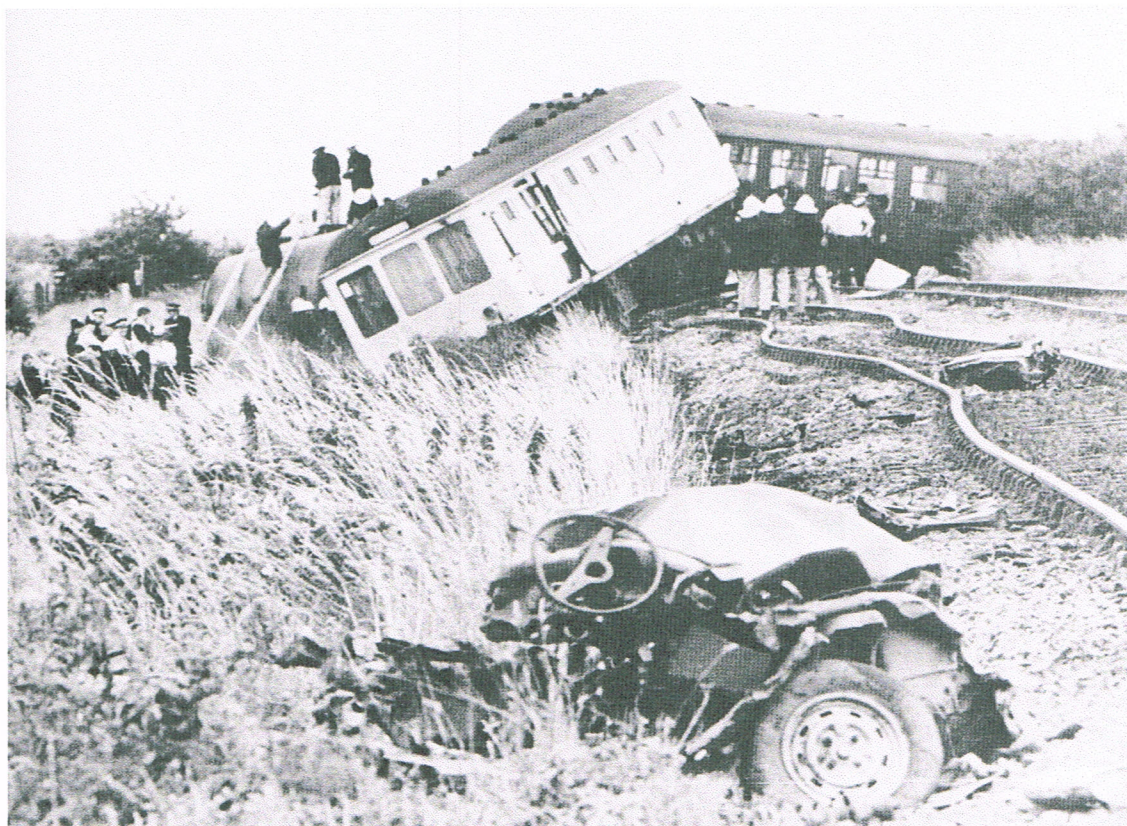
Figure 10.8

Lockington, AOCR LC, East Yorkshire, 26.7.86.

The results of the collision with a small van, seen in foreground. The leading carriage of the train is facing the opposite direction to the way it was travelling, e.g. away from the photographer.
