**Appendix K**  
**Other Level Crossing and**  
**Road Rail Interface Issues**  
Photographic Evidence

### K.1 Introduction

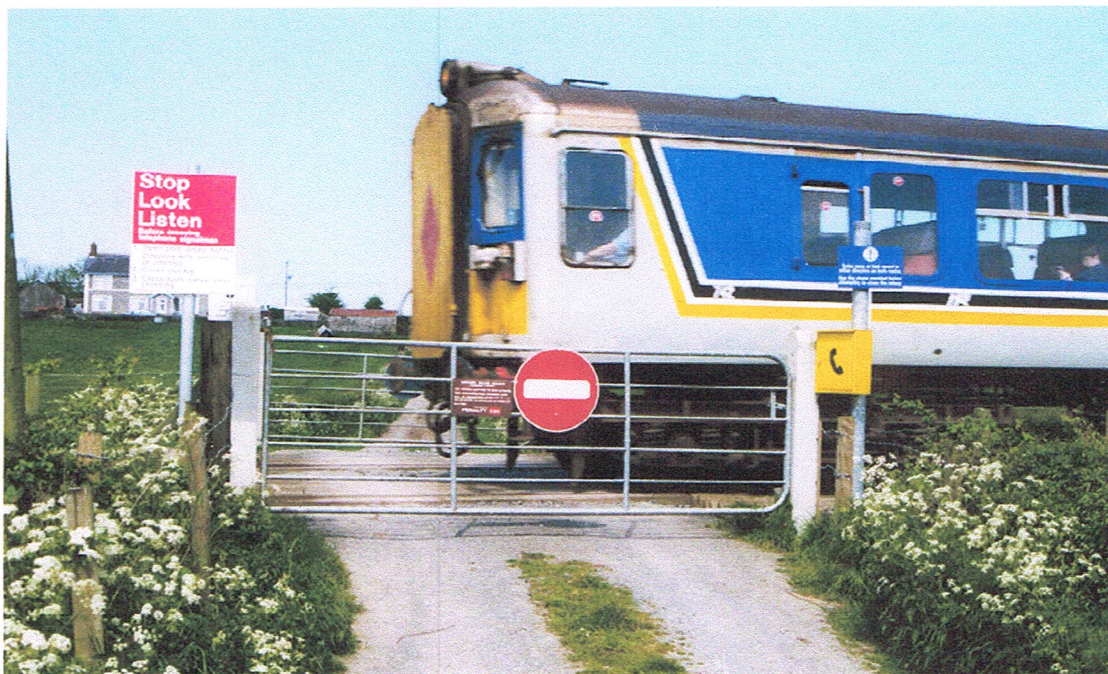
*Figure K.8 (top) & Figure K.9 (bottom)*

*Swinedyke MSLUWG LC, Lincolnshire (top) Robinson's Occupation Crossing, NIR (bottom); Gates left open by the last user, thus endangering future users, particularly youngsters who may not fully appreciate the dangers. Accommodation and Occupation crossings cause railways regular safety scares with such behaviour and farm vehicles etc. The fine for leaving gates open is £50 on NIR; It should be far higher and rigorously enforced by the courts.*
